BUILDING DAMAGE DUE TO 2008 WENCHUAN EARTHQUAKE AND COOPERATIVE ACTIVITIES ON DAMAGE RESTORATION BY JAPANESE EXPERTS

Yoshiaki NAKANO¹, Masaki MAEDA², Joji SAKUTA³, and Masanobu SAKASHITA⁴

Key Words: Sichuan (Wenchuan) Earthquake, Damage Restoration, Technical Support Liaison Council

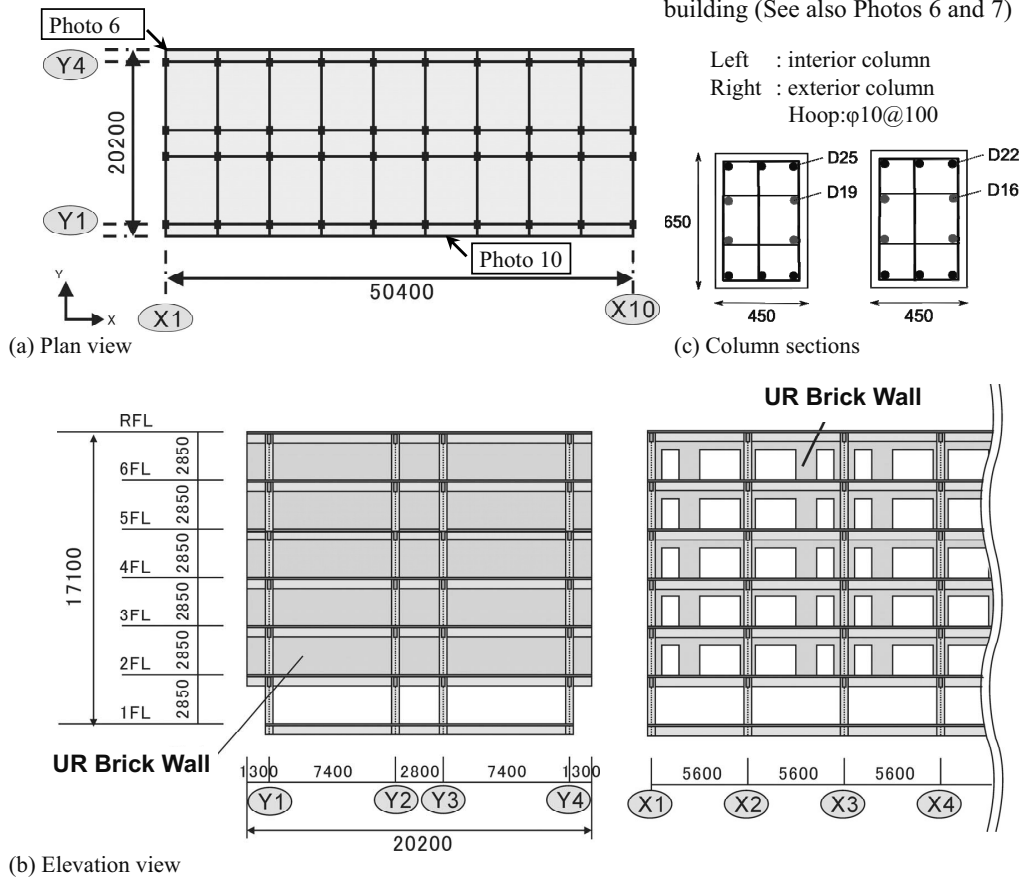
Figure 2. Structural configuration and column size of example RC building

Almost all columns in the first story form plastic hinges both at their top and bottom, causing concrete crushing and rebar buckling (Photos 6 and 7) resulting in the soft first story mechanism with a residual lateral drift of approximately 10% of the story height. No major damage is, however, found in upper stories.

Then Schemes 3 and 4, which do not employ re-centering of the building, are proposed to facilitate the restoration work. It should be noted, however, that the column size after Schemes 3 and 4 would be almost twice as large as the original since the new RC element around the original section needs to be large enough to jacket the tilted column and new reinforcement. In Scheme 3, as is

In Schemes 5 and 6, additional lateral resisting elements are provided in the first story as shown in Figure 3. Scheme 5 aims to increase in lateral resistance through providing wing walls in each column, while Scheme 6 provides six sets of RC shear walls which are expected to provide high lateral resistance. In both cases, the contribution of new sections is simply estimated by the product of the sectional area A_w and the ultimate shear strength τ_u of the wall, where τ_u is assumed 2 N/mm^2 . Since the original structure is designed to absorb seismic energy through large plastic deformation rather than high lateral resistance, I_s index after scheme 6 is still much lower than the original and the six sets of new shear walls may not be sufficient to fully improve the overall behavior of the structure as shown in Table 2.
