INTERPRETATION OF BREACHING FAILURE OF HATTIAN BALA LANDSLIDE DAM FORMED BY 2005 KASHMIR EARTHQUAKE WITH EXPERIMENTAL APPROACH

ABSTRACT: On February 9, 2010, a natural landslide dam at Hattian Bala of Pakistan, which was formed in the Oct 8, 2005 Kashmir earthquake, failed due to incessant rains. The landslide dam was formed of mainly crushed mudstones and sandstones which can be easily deteriorated through their slaking process. Under this threat, we had made four surveys to monitor the landform changes at about half-year's regular interval since June 2008. The back erosion at the toe part of the dam was first observed in the third field survey of June 2009. GPS-measured displacements conducted in both June and November 2009 showed a settlement of the crest part and slight uplift near the toe where the overflowed water fell in the eroded gully. We performed slaking and direct shear tests on prepared samples of crushed mudstones and sandstones with some materials taken in-situ to understand slaking effects on their stress-deformation characteristics. A significant creep deformation and a reduction in the peak strength were observed as the slaking developed in the mudstone specimen

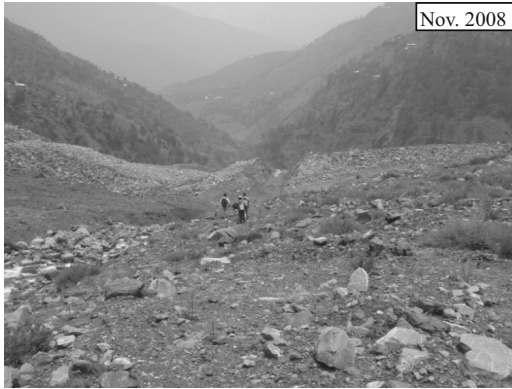
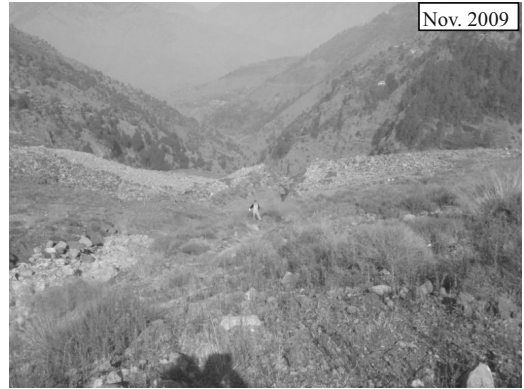
Photo 5 Middle portion of the dam (photography the downward from point B, latitude 34.138185°, longitude 73.730911°, c.f. Fig. 2)

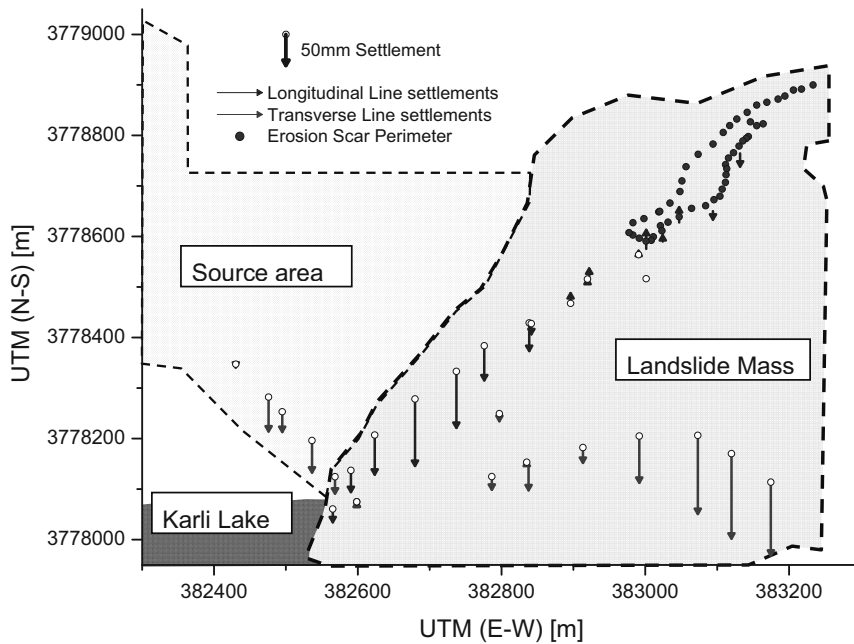
Figs. 2 shows that in-plane deformations are up to or comparable to 5 cm, No trend for the in plane movement vectors was observed indicating that the local deformations were dominant at the marked GPS points instead of integral body movement. On the other hand, the maximum settlement of about 10 cm was reached near the crest with the greatest thickness of dynamically placed loose debris mass presumed, while a slight uplift was observed where the spillway water falls in the gully eroded near the toe of the debris mass.

Figure 3 Settlements of landslide dam from June 2009 till November 2009 (after Sattar et al., 2010)

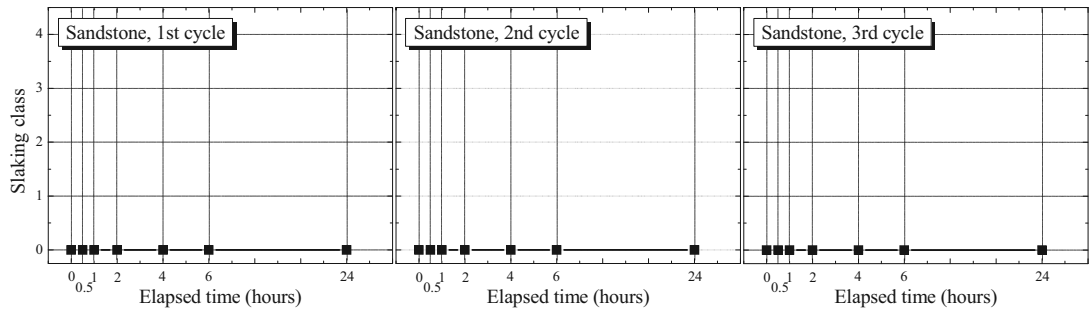
Fig. 5 and Photo 10 show that the mudstone specimen is sensitive to the duty cycle for accelerating slaking, while Fig. 4 and Photo 9 show little sign of slaking of the sandstone specimen (estimated slaking class = 0). Small cracks and small bubbles showed up on the surface of the mud specimen 30 minutes after the first pouring. The mudstone specimen however did not show any further changes in the subsequent wetting/drying cycles, and their shapes were kept intact (estimated slaking class = 1).

Figure 4 Change in slaking class of sandstone sample during accelerated slaking test

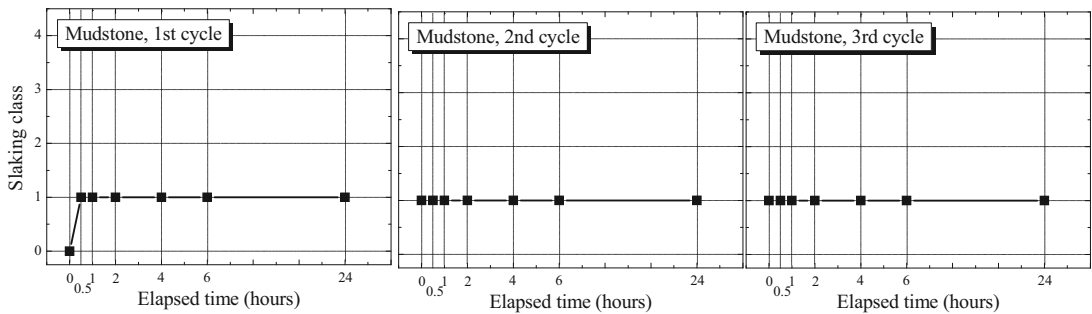
Figure 5 Change in slaking class of mudstone sample during accelerated slaking test

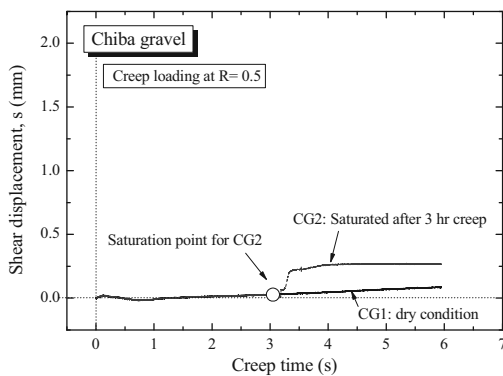
Figures 8 and 9 show time histories of shear displacements of Chiba gravel (CG1, CG2) and mudstone specimens (MS1, MS2), respectively. During creep loading, initial stress components ($\tau= 50$ kPa and $\sigma_v= 100$ kPa) were kept unchanged. In the case of CG1 and MS1, the creep shear displacement gradually increased as the time went on, and then the buildup of displacements was almost terminated after 6 hours creep.

Figure 8 Effect of slaking on creep deformation on Chiba gravel (as sandstone)

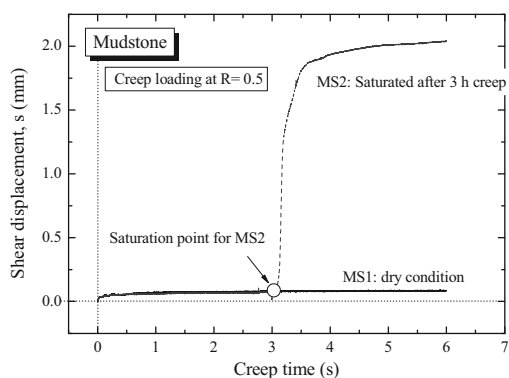
Figure 9 Effect of slaking on creep deformation on mudstone

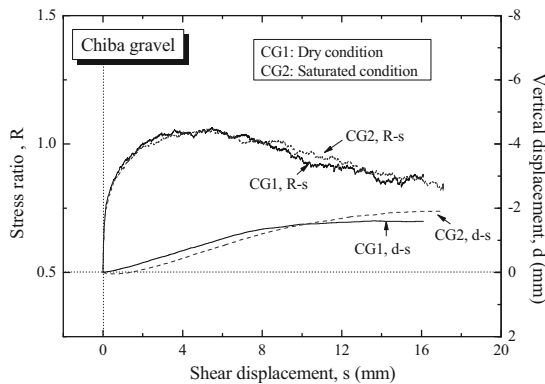
The stress-deformation curves for Chiba gravel samples in Fig. 10 are less sensitive to either drying or wetting process, while those for the mudstone specimens are highly susceptible to the change in the degree of saturation. The curves for dry specimen of mudstone (MS1) in Fig 11 exhibit clearly some dilative and strain-softening features like those for Chiba gravel samples (CG1 and CG2). On the other hand, the saturated mudstone specimen (MS2) did not show the strain-softening behavior and the specimen continued to be compressed during the shearing without exhibiting any dilative features. Such stress-deformation characteristics were generally common to soft soil materials, indicating that the mechanical properties of the examined mudstone deteriorated through its slaking process due to wetting during the creep loading.

Figure 10 Effect of slaking on stress-deformation characteristics on Chiba gravel (as sandstone)

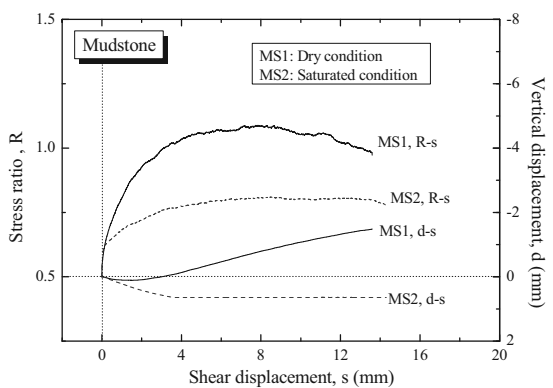
Figure 11 Effect of slaking on stress-deformation characteristics on mudstone
