Survey of September 30, 2009 Sumatra Earthquake

Muneyoshi Numada¹, Shigeru Miwa², Ömer AYDAN³ and Masanori Hamada⁴

Key Words: Sumatra Earthquake, Masonry structure, Liquefaction, Tsunami, Disaster survey

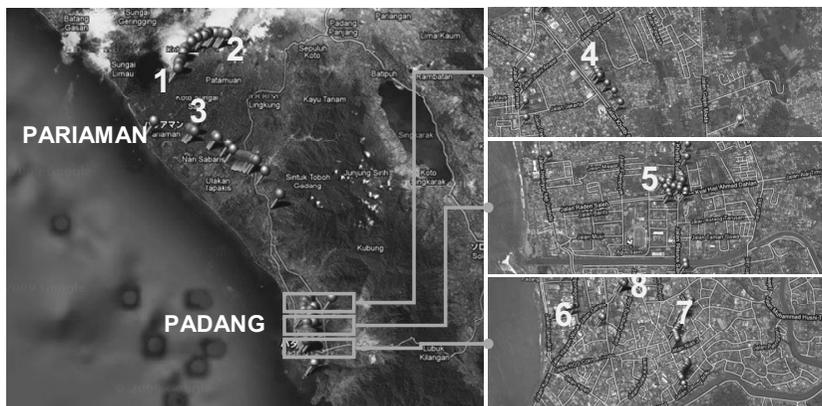
Figure 1. Damaged structures in Padang and Pariaman on Google map

Over 300 building were briefly observed in a survey of the Padang and Pariaman area. In **Figure 1** blue sticks mark the observed damaged buildings. Structures affected by this earthquake were primarily low-rise residential masonry, hotel buildings, government offices and industrial facilities.

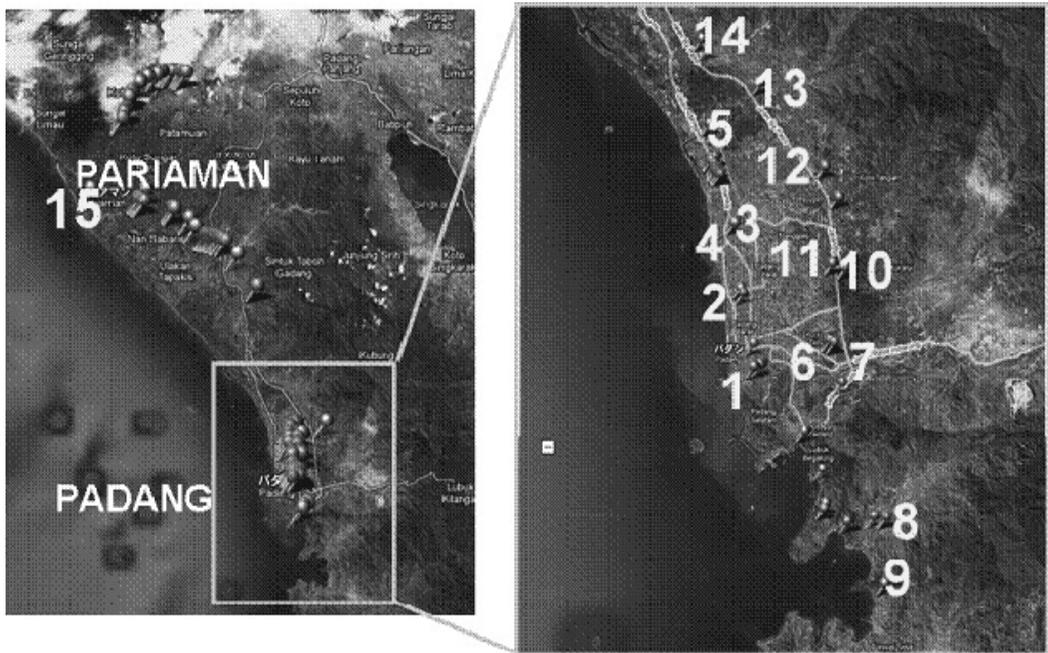
Figure 3. Surveyed bridges in Padang and Pariaman

An assessment of 15 bridges in Padang (14 bridges) and Pariaman (1 bridge) found no significant damage from this earthquake (**Figure 3**). The types of bridges in the epicentral area are mainly truss or simple beam bridges (**Table 1**). The earthquake shaking did not cause any visible damage to the bridge, roadways even though they were near the epicenter of the earthquake. Damage to bridges was mainly caused by the failure of approach embankments and uneven settlement of piers. However, almost all bridges were open to traffic with speed limitation.

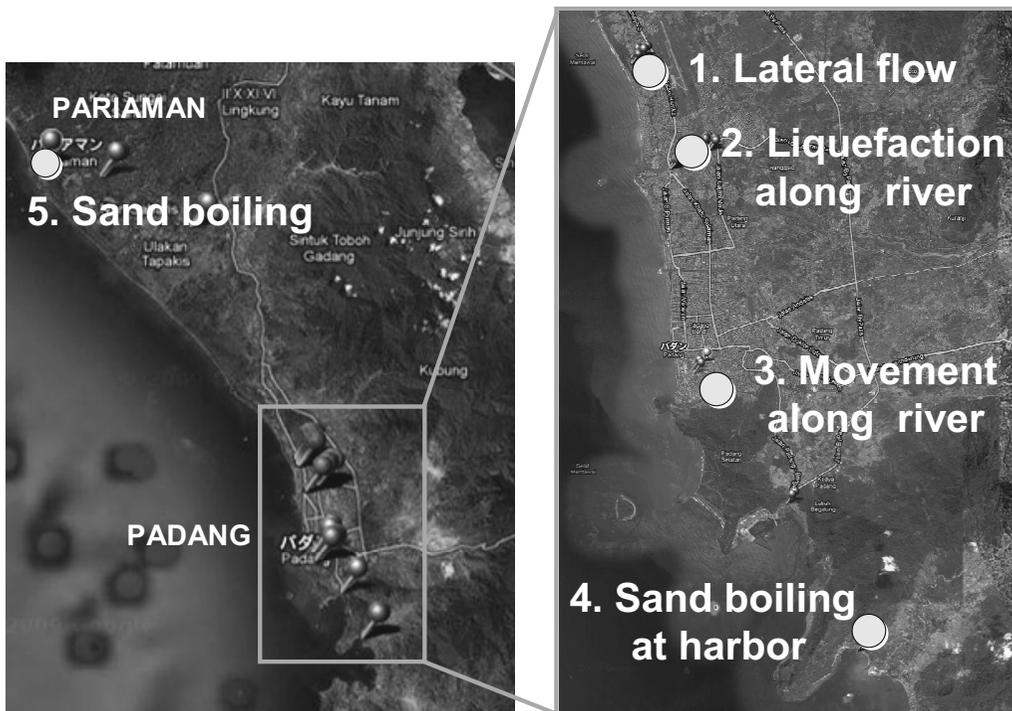
Figure 10. Geological damaged point

The most remarkable geotechnical damage was caused by liquefaction and accompanying lateral movement. **Figure 10** shows the surveyed area with geotechnical damage along the sea side or the river in Padang and Pariaman.

Liquefaction was also observed at Points 2 and 3 along the river on the sandy ground (**Figure 12**). Sand boils was observed at Points 4 and 5. Since the ground in this region consisted of a sandy layer, liquefaction easily occurred due to intense shaking. Fortunately, no damage occurred at the sea port at Point 4.
