LIQUEFACTION-INDUCED DAMAGE CAUSED BY THE 2010 DARFIELD EARTHQUAKE, NEW ZEALAND

Takashi KIYOTA¹, Mitsu OKAMURA², Hirofumi TOYOTA³ and Misko CUBRINOVSKI⁴

Key Words: Darfield earthquake, Liquefaction, Field reconnaissance, Swedish weight sounding test

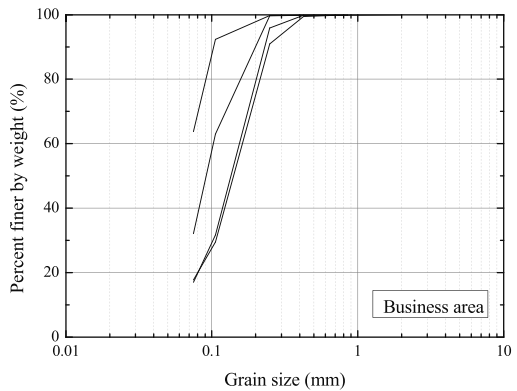
Figure 5 Grain size curves of boiled sands in Business area

Figure 5 shows grain size curves of boiled sands that were retrieved from the Business area. Most of their fines contents were less than 30 %, while the one from site 22 was higher than 60 % without plasticity.

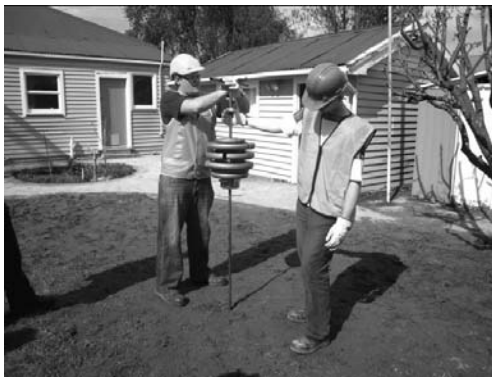
At site 7, significant liquefaction occurred in the residential district. A large amount of boiled sand could be observed at their backyards (Photo 6). The boiled sand covered ground surface with a thickness of 30 cm as shown in Photo 7. A number of housing floors suffered from cracking that was caused by uneven settlement of the ground after liquefaction.

Photo 8 SWS test (Site 7 in Fig. 5). Behind of experimenters, there is house suffered from cracking.

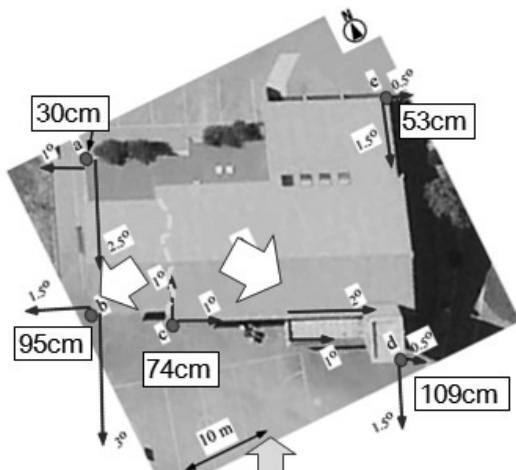
At site 26, St. Paul's Church that is located near the Avon-river suffered from uneven settlement. As shown in Figure 8, the settlements over 30 cm were measured at each side of cracking at the center part of the church, and the maximum settlement of 109 cm was measured at the tall structure. In addition, the pavement of parking lot around the building also suffered from cracking for a maximum differential settlement of about 50 cm as shown in Photo 9. These damages may have been caused by liquefaction because the extensive sand boiling occurred around the church.

Photo 9 Pavement around St Paul's church suffered from large cracking and settlement (Site 26 in Fig. 6)

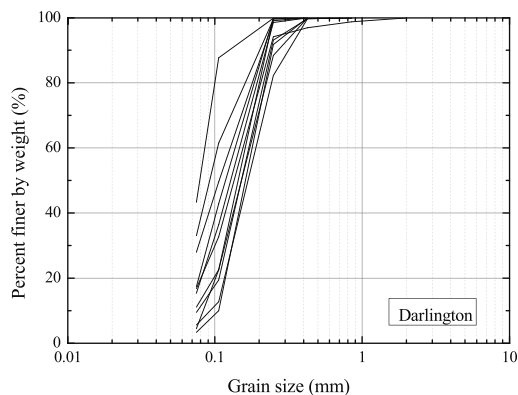
Figure 10 Grain size curves of boiled sands in Dallington area

Figure 10 shows grain size curves of boiled sands that were retrieved from the Dallington area. Most of their fines contents were less than 20 %, while those in the Porritt Park (site 22) were higher than 30 %.

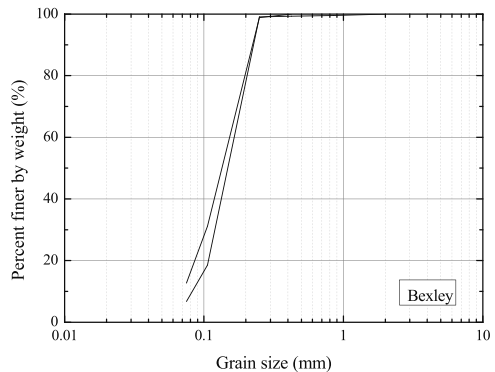
Figure 13 Grain size curves of boiled sands in Bexley area

Figure 12a) shows the result of SWS tests at site 93 that were conducted at the side of damaged house (Photo 12). The groundwater level was about 1.5m from the ground surface, below which very soft sandy soil deposits with N_{SPT} values less than 5 could be found for a thickness of about 4 m. This suggests that the compaction work had not been properly-conducted when the landfill was constructed. The boiled sand that was retrieved at the same location of SWS test was fine sand with D_{50} of 0.13mm and fines content of 12% as shown in Fig. 13.

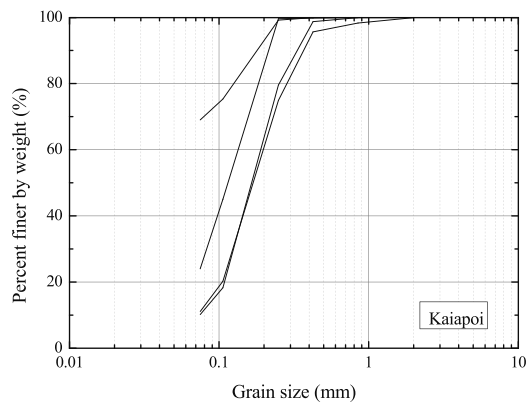
Figure 16 Grain size curves of boiled sands in Kaiapoi city

At site 109, a boathouse that is located on the levee suffered from uneven settlement as shown in Photo 13. At site 110, the ground surface of the levee suffered from significant cracking having the maximum opening of 1 m as shown in Photo 14. The groundwater could not be found in the large cracking, and the material of the levee was dense gravelly sandy soils that were not expected to be liquefied. Therefore, it can be considered that the liquefaction occurred in sandy layer beneath the levee and caused above damages. In fact, the sand boiling could be observed at the base of the levee, and the boiled sandy soil was different from the above gravelly soils. The boiled sand that was retrieved at the base of levee was fine sand with D_{50} of 0.15 mm and fines content of 20 % as shown in Fig. 16.

Reportedly, the residential area on the right side of the tributary had been elevated by soil filling about 5 years ago. High damage ratio of houses was observed along the margins of landfill as was seen in Bexley area. Typical damage of house due to liquefaction-induced ground deformation at the margin of filling in this area is shown in Photo 15. The house was caught up in the ground movement, and suffered from significant leaning to the slope side. The boiled sand that was retrieved at this house has fines content of 70 % as shown in Fig. 16. However, it could be liquefied because it has no plasticity.
