PILES FOR RC/STEEL-FRAME BUILDINGS PULLED UP BY TSUNAMI AT ONAGAWA TOWN, IN THE MARCH 11th 2011 EAST JAPAN EARTHQUAKE

Kazuo KONAGAI¹, Takashi KIYOTA² and Hiroyuki KYOKAWA³

ABSTRACT: The entire stretch of indented Tohoku-Pacific coast was seriously engulfed by tsunami caused by the East Japan earthquake on March 11th, 2011. One of the most noteworthy events seen in Onagawa was that piles supporting RC and/or steel-frame buildings were uprooted, and the buildings were carried over several ten meters distances. This report describes details of the tsunami-driven four buildings.

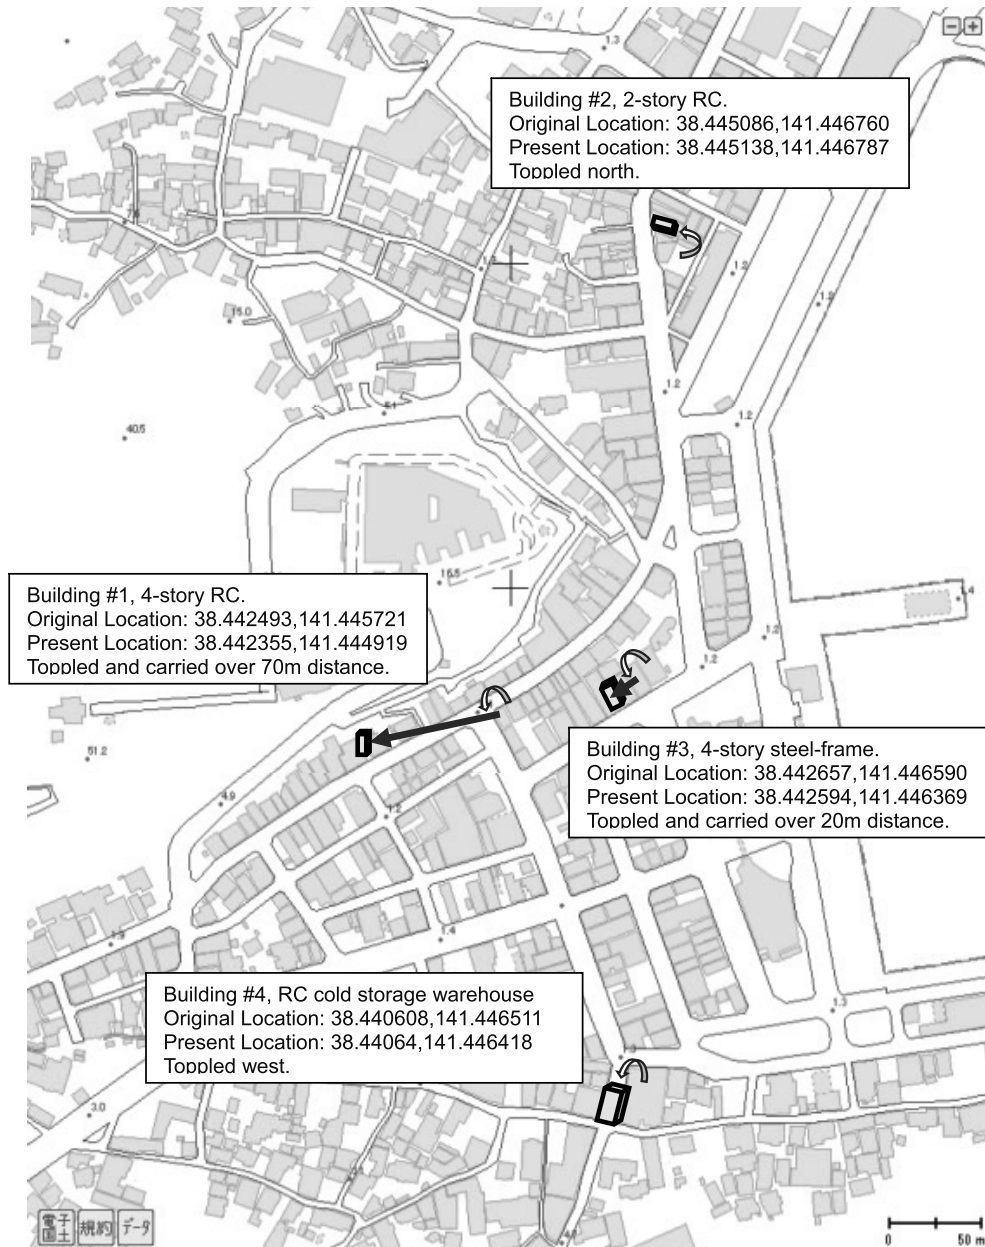
Figure 2 Locations of uprooted pile-supported buildings in Onagawa (after Cyber-Japan²⁾)

Figure 2 shows the downtown center of Onagawa, facing Onagawa Bay. There were at least four pile-supported buildings found toppled and /or carried over some distances. Piles are all of PHC (Pretension type centrifugal High strength pre-stressed Concrete) type.
