THE BREACHED EARTH-FILL DAM FOLLOWING THE 2011 OFF THE PACIFIC COAST OF TOHOKU EARTHQUAKE

Hiroyuki KYOKAWA¹, Kazuo KONAGAI², Takashi KIYOTA³, Toshihiko KATAGIRI⁴ and
Zaheer Abbas KAZMI⁵

ABSTRACT: Fujinuma dam, an earth-fill dam for irrigation located in Sukagawa City, Fukushima prefecture, was breached in the 2011 Off the Pacific Coast of East Japan earthquake. The water from the breached dam scoured its downstream valley floor and walls, and developed into a debris flow. The debris mass flushed a village downstream leaving 8 dead and 1 missing. The authors made a survey along the stream channel of the debris flow. During their survey, the breached dam body was LiDAR surveyed for its entire 3D image. With the findings from the survey, this paper discusses a possible mechanism of the dam breaching.

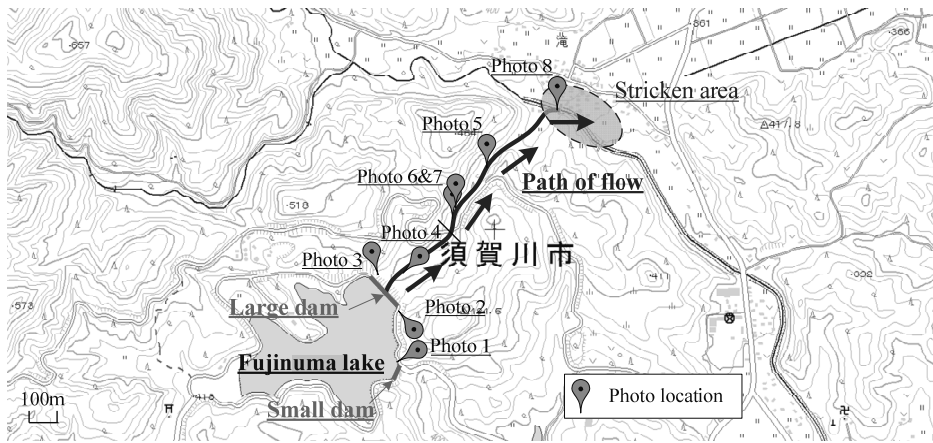
Fig. 2 Survey map (modified from Geospatial Information Authority of Japan, 2011)

Fig 2 shows the route for the survey along the debris flow channel and photo-shooting locations. There were large and small earth-fill dams stopping the water of the Fujinuma reservoir as shown in Fig. 2.

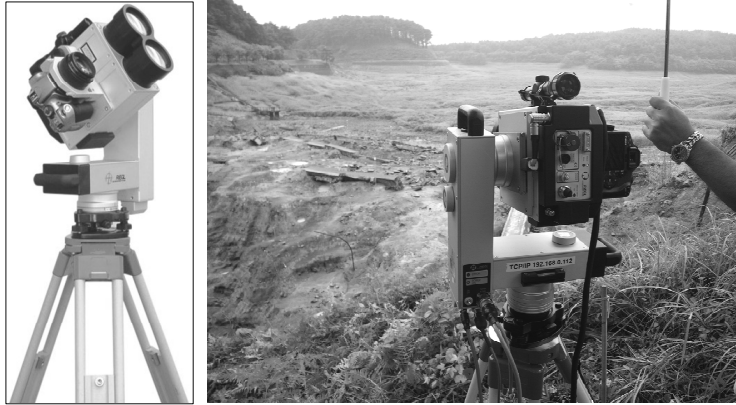
Photo 7 LPM-321 (left: LPM-321, right: laser-scanning scene)

The breached dam body was LiDAR surveyed for its entire 3D image using the laser profile measuring system LPM-321 (See Photo 7). LPM-321 is based on the time-of-flight measurement of short laser pulse. It covers 6000m distance without reflector (@ Laser class 1M), with a wide view field of $150^{\circ} \times 360^{\circ}$, an expected maximum error of 25mm and measurement rate of maximum 1000 points / sec. Using a high resolution digital camera along with it, a RGB color image can be obtained for all laser-shot points. The dam body was laser-scanned on Aug. 21st from three different locations: two were on the right abutment and one on the left abutment. The measured 3D digital surface models were then combined to be the entire terrain model of the dam body(Fig.4).
