# DAMAGE TO NON-STRUCTURAL COMPONENTS IN LARGE PUBLIC SPACES BY THE GREAT EAST JAPAN EARTHQUAKE

Ken'ichi KAWAGUCHI<sup>1</sup>, Yoshiya TANIGUCHI<sup>2</sup>, Yuki OZAWA<sup>3</sup>,  
Yosuke NAKASO<sup>4</sup> and Sho WATANABE<sup>5</sup>

**ABSTRACT:** This is an investigation report on damage to non-structural components in large public spaces by the “Great East Japan Earthquake.” This paper mainly reports the field survey on damages to non-structural components in five large public spaces. Distribution of buildings which suffered ceiling damage during the “2011 off the Pacific Coast of Tohoku Earthquake” and its aftershocks is also shown by using data on web sites. The distribution clarifies that failure of ceilings occurred in the area of over 5-Lower intensity. Therefore, the distribution is likely to reach widely.

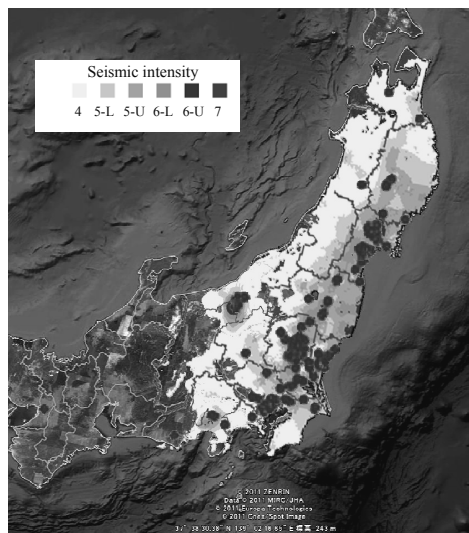
**Figure 1.** Distribution of buildings which suffered ceiling damage

The distribution of buildings which suffered damage to ceilings during the “2011 off the Pacific Coast of Tohoku Earthquake” and its aftershocks (**Table 2**) is shown in **Figure 1**. This distribution is based on reports on web sites until May 20, 2011. Several estimated seismic intensity distributions are superimposed on the map. According to the distribution, most ceiling damages reported on web sites were in the area of over 5-Lower intensity. This is the same tendency confirmed by the authors in the “Mid Niigata Prefecture Earthquake” in October 2004. Since ceiling damages tend to occur on smaller seismic intensity than damages of building structure, the distribution is likely to reach widely.
