FAILURE OF CEILINGS IN AN AIRPORT BUILDING DURING THE 2011 OFF THE PACIFIC COAST OF TOHOKU EARTHQUAKE AND ESTIMATION OF ITS IMPACT

Yasushi OBA¹, Yosuke NAKASO² and Ken'ichi KAWAGUCHI³

ABSTRACT: This is an investigation report on the failure of ceilings at the entrance hall of an airport building with well space during the “2011 off the Pacific Coast of Tohoku Earthquake”. Although nobody was injured by the accident, the height of the ceilings was so high that the estimation of the extent of possible damage to human body is worth to understand the risk of such failure. The impact estimation was carried out by using a broadcasting video record taken accidentally during the earthquake and the results of ceiling dropping test to a dummy head.

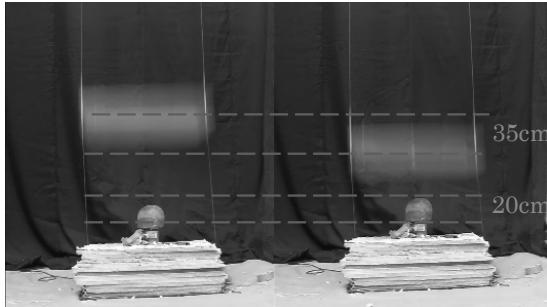
Figure 13. Video of test ($dt=0.034\text{sec}$)

We attempt to estimate falling velocity from video of the test. It is estimated about 10m/s in **Figure 13**.
 $0.35 / 0.034 \approx 10 \text{ [m/s]}$

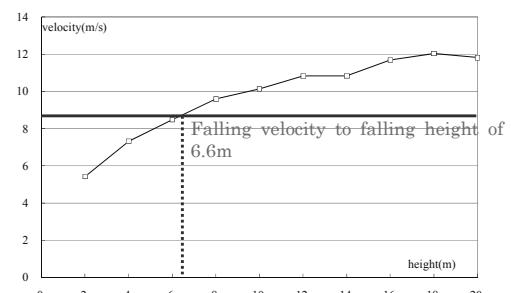
Figure 17. Velocity of the underlayered ceiling

It is assumed that a man of 170 cm tall stands just under the ceiling in the accident. Estimated from the TV video, falling velocity of the ceiling at the height of 170 cm above the floor is approximately 8.5 m/s. Since the ceiling height is 8.3 m, the velocity may be equal to one in condition that falling height is 6.6 m. Here the estimated velocity is verified with relation between falling height and velocity tested in Ref. 3 (Figure 17). The falling velocity of underlayered ceiling with furring channels to falling height of 6.6 m is 8.7 m/s. It agrees approximately with 8.5 m/s estimated above. Therefore, in this case it is assumed that the velocity just before impact of the ceiling falling in a body and one of ceiling the size of 910 mm×910 mm in the test are approximately equivalent for same falling height.
