DAMAGE TO NON-STRUCTURAL COMPONENTS IN A LARGE ROOF BUILDING DURING THE 2011 OFF THE PACIFIC COAST OF TOHOKU EARTHQUAKE AND ITS AFTERSHOCKS AND RECOVERY OF CEILING USING MEMBRANE MATERIALS

Ken'ichi KAWAGUCHI¹, Yoshiro OGI², Yosuke NAKASO³
Kazutaka UEMURA⁴ and Yasushi OBA⁴

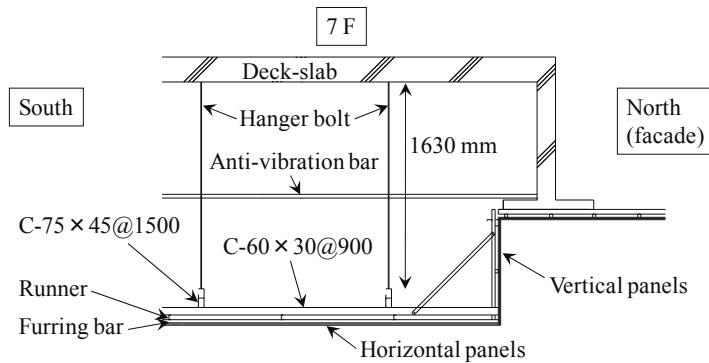
As shown in **Figure 6**, panels of the eastern ceiling failed and fell off with furring bars in a long and thin area next to the smoke barrier. Glass panels of the smoke barrier also broke. And about 30 vertical panels (approximately 0.8 m by 0.9 m) in the vicinity of the facade failed with furring bars in several regions along 25-m length (**Figure 7**). Several small parts of the ceiling next to walls also failed. Two hardened glass panels of the facade broken. One of the hanging art objects also fell off.

Figure 5. Cross section of the eastern ceiling at the entrance hall
