# PRELIMINARY STUDY OF OBSERVED RESPONSE OF SUSPENDED CEILING DURING AFTERSHOCKS IN A LARGE ROOF BUILDING

**ABSTRACT:** This paper reports results of dynamic characteristics of damaged suspended ceiling in the “National Museum of Emerging Science and Innovation (Miraikan),” Tokyo, Japan, by using observed motion data during aftershocks of the “2011 off the Pacific Coast of Tohoku Earthquake.” Analyses of horizontal motion data for the ceiling, the building structure, and the ground next to Miraikan recorded during aftershocks showed that the natural frequency of the ceiling was lower than that of the building structure. However, the structural characteristics of the building strongly affected the ceiling’s response.

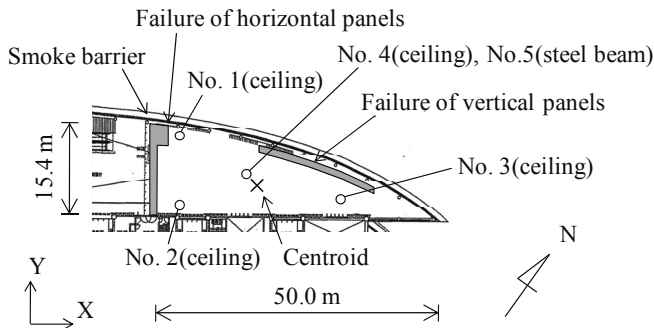
**Figure 5.** Location of accelerometers at the entrance hall

We used wireless measurement system with capacitive tri-axial accelerometers (**Table 2**). As illustrated in **Figure 5**, four accelerometers (No. 1 to 4) were put on the upper side of the ceiling, and one accelerometer (No. 5) was put on a steel beam (H-1200×300) of the building structure just above the No. 4 point.
