SURVEY REPORT OF 2011 VAN EARTHQUAKE IN TURKEY

ABSTRACT: On October 23, 2011 at 10:41:21 UTC, an intense earthquake ($M_w=7.1$ according to USGS) occurred in eastern Turkey. Another earthquake ($M_w=5.6$ according to USGS) occurred around Van city on November 9, 2011 which also caused the collapse of buildings weakened by the first shock. AIJ and JAEE organized a survey team after the events. The team was dispatched to Van and Ercis cities, Turkey, and conducted initial damage assessment in the damaged area with the survey groups from Yuzuncu Yil University, Bogazici University and mainly Istanbul Technical University. This report outlines the findings obtained from the survey of the damaged area.

Key Words: 2011 Van earthquake, damage reconnaissance, R/C buildings, Masonry buildings, Damage classification

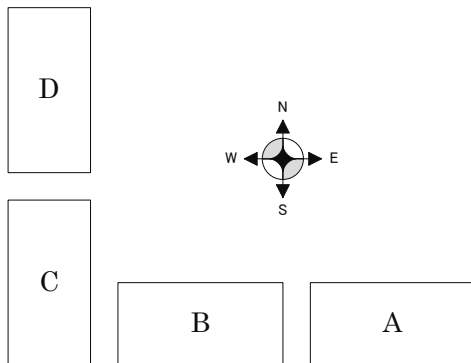
Figure 3 Building layout

Four apartment buildings as shown in Photo 6 were investigated. The buildings are six stories reinforced concrete buildings, and their layout is shown in Figure 3. The first and second floor plan with the damage level in the longitudinal direction of structural members of Building A, B, C and D are shown in Figure 4 to Figure 7, respectively. Photo 7(a) shows details of shear failure at the top of a south side column. The beam-column joint failure was observed in the south-east corner of Building C as shown in Photo 7(b).

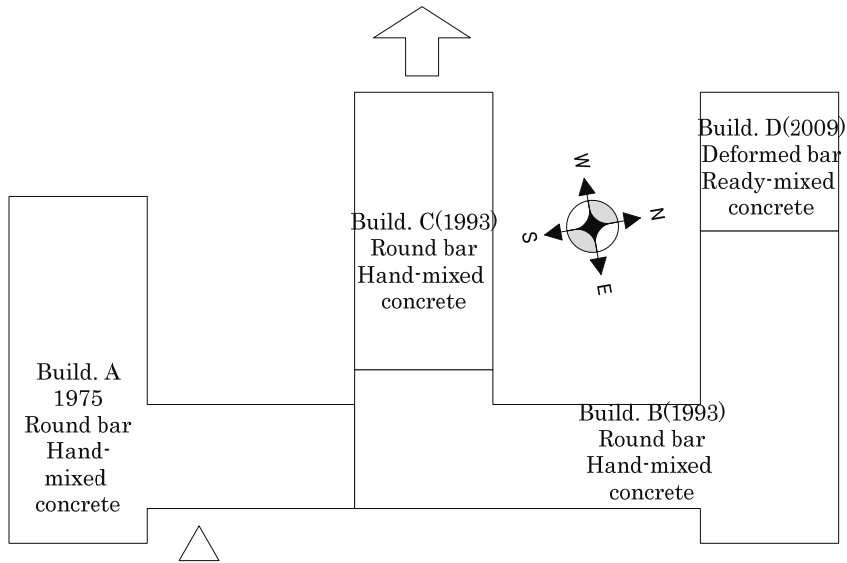
Figure 4 Plan of the main building

The building has three stories and one semibasement floor. South-east side of the building is shown in Photo 8. The plan of the main building is shown in Figure 4. The building is separated into three portions. They are not connected but have gap between buildings. Building A was constructed in 1975 with round bar and hand-mixed concrete. Building B and C were constructed in 1993 with round bar and hand-mixed concrete. Building D is new and was constructed in 2009 with deformed bar and ready-mixed concrete.

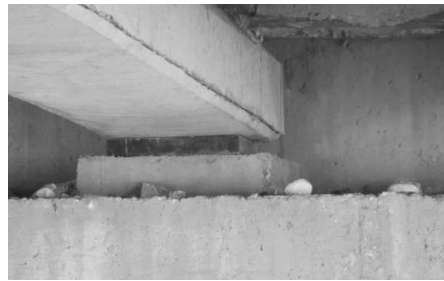
The type of bridges in damaged area was mainly simple concrete beam bridge (Photo 10(a)). Some bridges employed rubber bearings to have the effect of the seismic isolation as well as for consideration of thermal effects (Photo 10(b)). The use of airport terminal building was limited due to the damage of airport building. It should be mentioned the damage observed by our team was limited with the damages of non-structural members. On the other hand, the airplane service was completely recovered by utilization the new terminal building, which was taken into service right after the second earthquake (Nov.9th) (Photo 10(c)). The railway is normally used for international logistic service. The railway was available after the earthquake with no heavy damage (Photo 10(d)). The small scale industrial structures in the old industry zone were partially damaged. The structural systems of typical manufacturing structures were RC frames and infill wall of concrete blocks (Photo 11(a)). Photo 11(b) shows the total collapse of a manufacturing building. The adobe houses were also severely damaged (Photo 12(a)). The out of plane failure on the wall was observed (Photo 12(b)).

(b) Rubber bearing of photo(a)

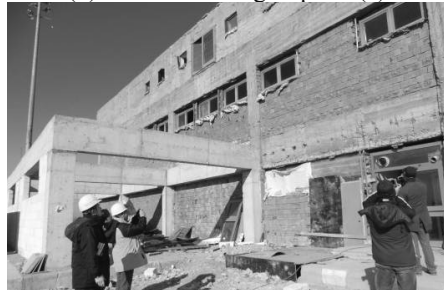
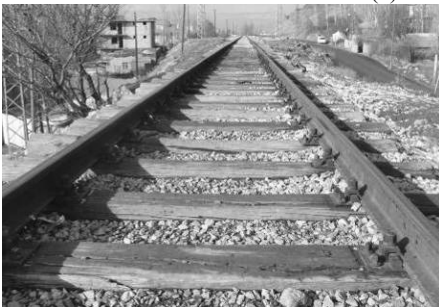
(d) Railway with no significant damage

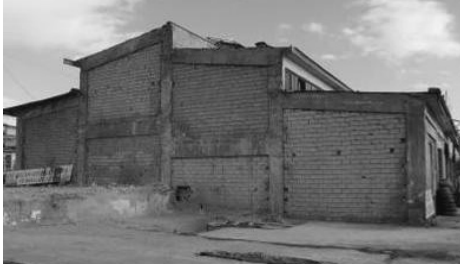
(a) Typical industrial structure
