DAMAGE TO NON-STRUCTURAL COMPONENTS IN LARGE ROOMS BY THE JAPAN EARTHQUAKE, MARCH 11TH, 2011

Ken'ichi KAWAGUCHI¹

ABSTRACT: The author has kept warning the danger of the failure of non-structural components in large rooms since Kobe earthquake in 1995. The Japan earthquake in 2011 has brought about the damage to the non-structural components, especially to the suspended ceilings in large rooms, in a very wide scale. The examples of failure are reported and discussed.

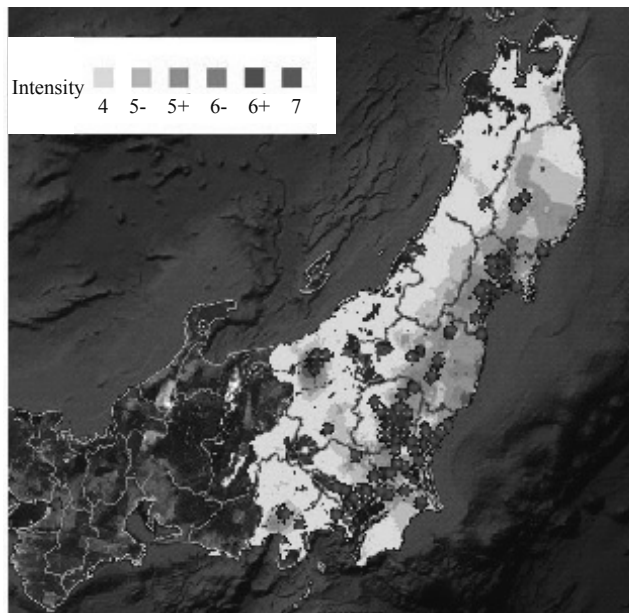
Figure 3. The area of intensity five or higher (colored in orange) and 186 buildings that had failure of suspended ceilings

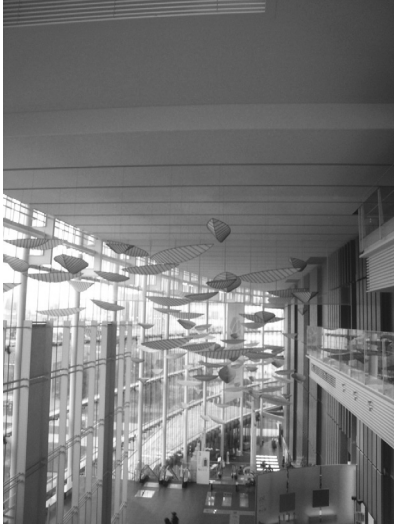
(a) View of the entrance hall before the quake

The National Museum of Emerging Science and Innovation is standing at an artificial island in Tokyo (**Figure 9**). The ceilings of the entrance hall of the museum were failed during the main shock and the after shock. The evacuation guidance by the museum staff was so well organized that nobody was injured. The director of the museum considered the accident seriously and decided not to recover the ceilings in the same style as they were. He asked the author to supervise the recovery plan. The author recommended using the lightest and most flexible material, membrane, for the new ceiling. The director removed all the remained conventional ceilings of the entrance hall and renewed it with the membrane ceiling, which hardly fails again and never injure people.

Figure 9. The National Museum of Emerging Science and Innovation
