# SINKHOLE DAMAGE IN ARMALA AREA IN POKHARA, NEPAL: A PRELIMINARY SURVEY REPORT

**ABSTRACT:** Nepal is a seismic prone country. There is a very high potential that an upcoming strong earthquake may have catastrophic consequences in Armala area, Pokhara Valley, where the unexpected formation of a substantial number of sinkholes is already in place since November 2013. In order to provide measures aimed at reducing sinkhole risk, new insights into the sinkhole cause and features is crucial. This paper reports on two damage surveys conducted in June and November 2014 by the Authors in Armala area, to investigate the cause of such sinkholes. Comparison of photos, taken in the two surveys, clearly indicates not only the formation of new sinkholes, but also the re-activation of sinkholes that were previously backfilled. By means of S-wave explorations and dynamic cone penetration tests, qualitative characterization of soil profile was attained and shallow weak soil layers, which are believed to be the location for future sinkholes, could be identified. Sinkhole cause are described and feasible countermeasures are proposed to mitigate sinkhole risk in Armala area.

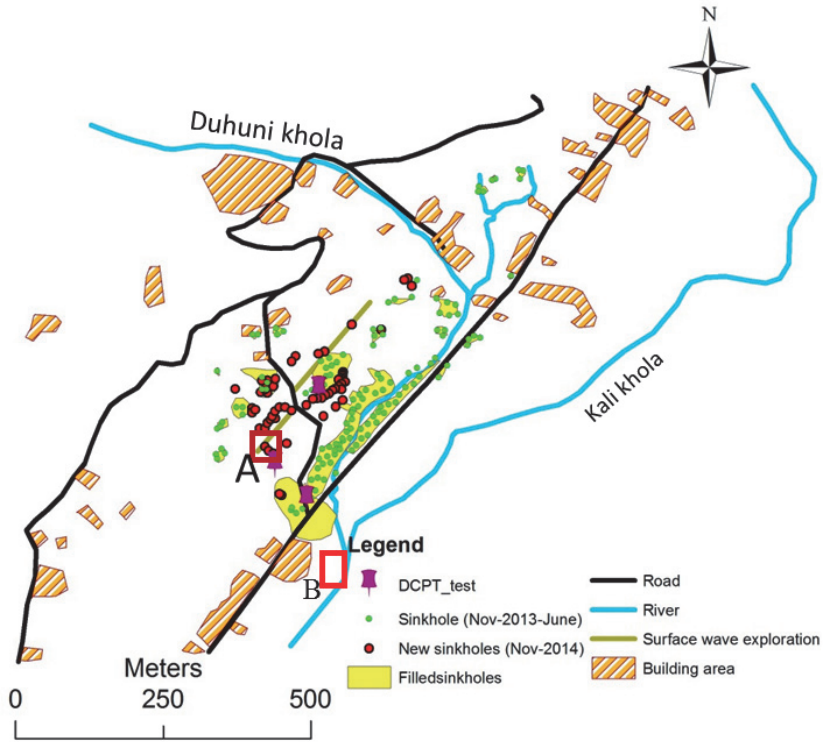
**Figure 4** Detailed map of the sinkhole damaged area in Armala

During the June 2014 survey, the trace of a number of sinkholes previously formed in November 2013 could be typically observed in both sides of the Duhuni Khola (green dots in Figure 4 and observation points 1 to 30 in Figure 5). All the sinkholes were completely filled, except for the sinkhole at point 6 (Figure 5). Originally, it had a diameter of about 10m and depth of about 7m. But, at the time of the survey, the upper part was already filled by sediments, and the measured depth was less than 4m.

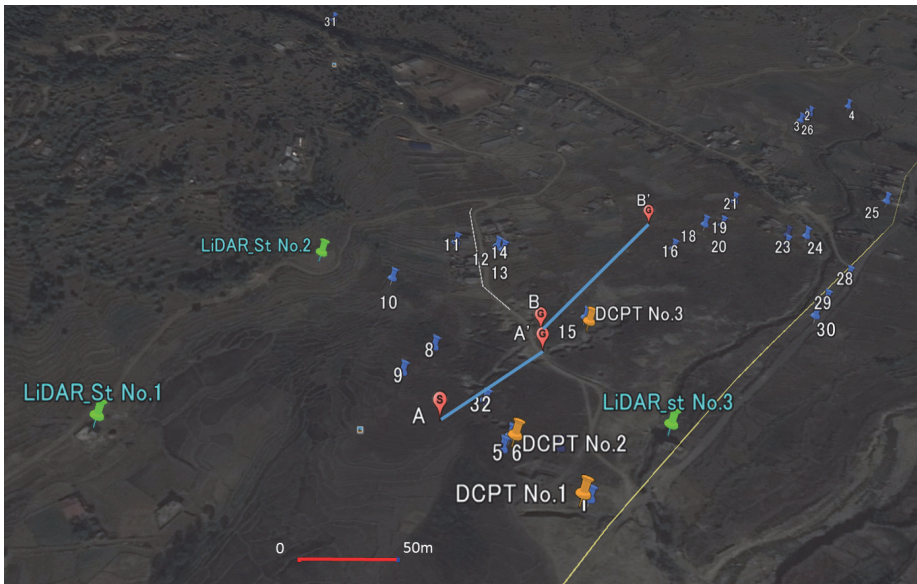
**Figure 5** Survey map of the Armala area

According to local residence the first sinkhole appeared in November 2013 at point 3 (Figure 5). Since then, more than 150 sinkholes developed in this area. A typical circular-shape sinkhole appeared in Nov. 2013 is shown in Figure 6(a) (mysansar.com).

The sinkholes affected not only the agricultural farmland. It also caused the collapse of cowshed [Figure 7\(a\)](#) at point 11 ([Figure 5](#)), and kitchen of the local residents [Figure 7\(b\)](#) at point 25 ([Figure 5](#)). Homeowner said that about 60 m<sup>3</sup> of filling material were used to fill the sinkhole shown in [Figure 7 \(a\)](#).

During the November 2014 survey, a number of sinkholes of recent formation (understood to be developed in August 2014) were mostly observed in the west side of the field survey area. In the map shown in [Figure 5](#), it can be seen that the new sinkholes (red dots) are concentrated on the western side

Among many, sinkholes N1, N2 and N3 in the area A in [Figure 5](#) were found of particular interests. They were developed in a delimited area of approximately 10×20 m, as shown in the schematic map reported in [Figure 10](#). They have a circular pattern and a diameter ranging from 4.6 m (N3) up to 6.8 m (N1). Their depth measured at the top of collapsed soil varied from 2.2 m (N1, N3) to a maximum of 3.5 m (N2). According to local residents, N1 was the first sinkhole to be formed. Few days later, N2 was caved-in and finally N3 was developed.

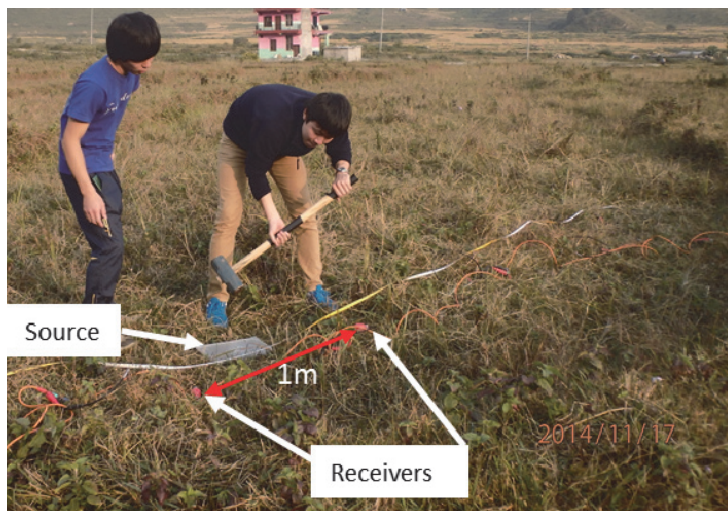
**Figure 13** Surface wave exploration method used in this investigation

The surveys were performed along two different patterns (two green lines) in Figure 4 and A-A' and B-B' in Figure 5 using surface wave exploration. The total length of survey is over 250 m. The testing conditions consist of: 24 vertical-component geo-phones deployed with 1 m interval; and a 5 kg hammer used as a source of surface waves. Source was also moved with 1 m interval. The nearest source to receiver offset was 0.5 m. An OYO MCSEIS-SW was used for data acquisition. Figure 13 shows typical surface wave exploration alignment used in this investigation.
