# REPORT ON SOME LARGE SPAN STRUCTURES DAMAGED DURING THE “2016 KUMAMOTO EARTHQUAKE”

**ABSTRACT:** The 2016 Kumamoto earthquake, that measured a maximum of seven on the JMA seismic intensity scale, occurred in Kyushu, Japan, in April, 2016. One of the two investigated buildings has a large membrane roof structure that normally has high earthquake resistance. It encloses a large space; nevertheless, it was not used as an evacuation center owing to the damage, not to the structural members, but to the non-structural components. Another building is a public hall that has a heavy ceiling for better acoustic performance. In this paper, the damage investigation of these two large-span structures in Kumamoto city is reported.

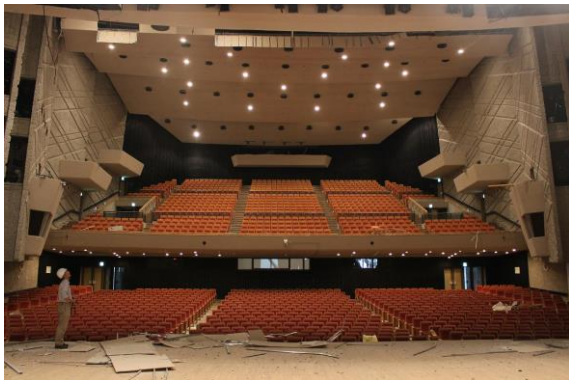
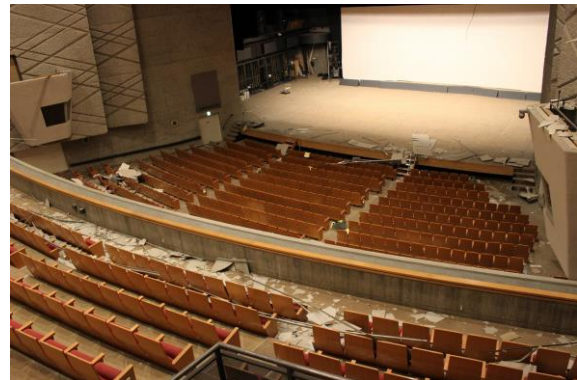
**Figure 3.** Internal view of the hall

The internal view is shown in **Figure 3**. **Figure 4** and **Figure 5** show the plan and section of the hall, respectively; the location where the ceiling fell from a height of 10 – 16 m is also shown in **Figure 5**. The observation was conducted from the floor in the hall without entering the space above the ceiling, owing to the danger of aftershocks. Therefore, the ceiling details were unfortunately unclear at this time. The suspended ceiling, mortar finish on 30 – 50 mm thick metal lath, installed on both sides of the stage and the 9.5 mm thick vertical gypsum boards installed in the center above the proscenium arch fell down. On both sides above the proscenium arch, shown at location A in **Figure 5**, the impact marks of the collision of the ceiling and the walls were observed. With regard to the vertical gypsum panels, the lighting equipment hanging in the front partially prevented the ceiling from falling. The ceiling installed directly under the ceiling room hung at location B in **Figure 5**, and the 6-mm thick calcium silicate ceiling fell down at location C in **Figure 5**. As mentioned, the ceiling materials differed according to location. The magnitude of the impact force caused by the fall of the ceiling is clear from **Figure 6**, especially in the case of the mortar finish on the metal lath. As shown in **Figure 7**, there was the danger of falling owing to aftershocks. Regarding further damage, the fall of the lighting covers (**Figure 8**) and the cracking of the floor above the duct space in the basement (**Figure 9**) were observed. It is considered that the crack occurred at the point of the floor overhanging the orchestra pit and the duct space, because of the vertical motion of the floor as a cantilever.

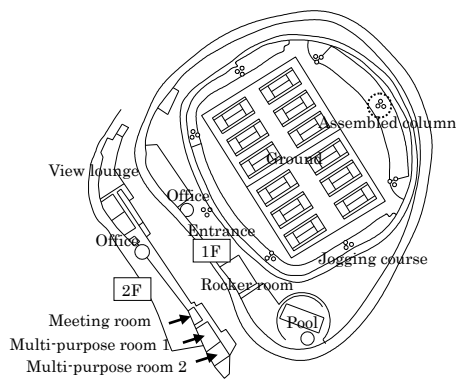
**Figure 12.** Plan

**Figure 12** shows the plan of the facility. The damage in each area is summarized in the following section. According to the staff, although the welds of the membrane in the amorphous area fell off during the earthquake, the area was mended prior to the investigation (**Figure 13**). In addition, the connection of the canopy and the columns along the circumference of the amorphous area was damaged. In the multi-purpose ground, numerous glass wool panels of 50-mm thickness, which were installed at the ring truss for acoustic performance, fell off. Cracks and exfoliation of the concrete were observed in the bearing of the truss frame. The strings of the membrane under the truss frame in the amorphous area were frayed. The damage to the membrane caused rain to leak in on multi-purpose room 1, the meeting room etc. In the meeting room, the cracks in the walls occurred as a result of the leaking rain. Multi-purpose room 1 was used as the training room; however, all training machines were moved to other rooms because of the rain leaking in from the torn movable membrane ceiling. In multi-purpose room 2, glass wool boards were placed on the heavy ceiling made of expanded metal.
