EXPERIMENT STUDY ON REDUCTION OF PP-BAND MESH CONNECTIVITY FOR RETROFITTING OF MASONRY STRUCTURE

Adnan Mahmood DAR¹, Saleem M.UMAIR², Muneyoshi NUMADA³
and Kimiro MEGURO⁴

ABSTRACT: Masonry construction is a very attractive and popular construction in different continents of the world. Polypropylene band (PP-band) retrofitting has been proposed as the retrofitting method for masonry structures in many under developing countries. In this paper, we have tested the effects of reduced numbers of connecting points of PP-band mesh by ¼ scale-models on shake table test. The fully connected (PPF) and the non-connected cases (PPN) were compared. The PPN model showed the effectiveness as for the retrofitting method.

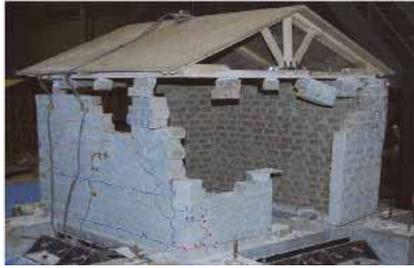
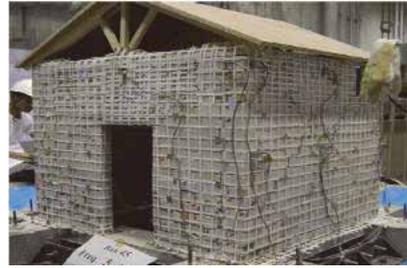
a) Non-retrofitted model

b) PP-band retrofitted model

Figure 1 Damaged condition of model house at frequency 5 Hz and acceleration 0.4 g

The single story houses with PP-band mesh were evaluated by the ¼ scale models with roof on shake table test. The seismic performances of the PP-band retrofitted models have been enhanced in comparison to non-retrofitted models as seen from **Figure 1**. The PP-band retrofitting method is economical and accessible everywhere in the world. This is the cheapest and affordable retrofitting solution for building in the seismic prone areas. Practical demonstrations of PP-band retrofitting method for the houses with two rooms in underdeveloped and disaster hit areas of Pakistan. PP-band mesh was used inside and outside of the wall and the surface finish was applied later on (**Figure 2**)

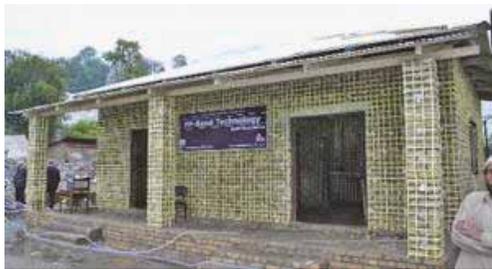
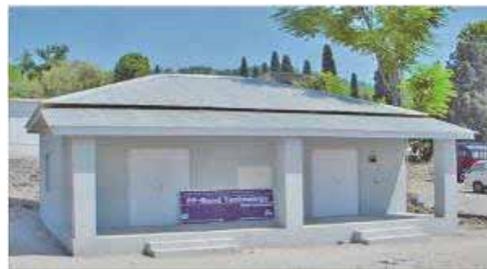
a) PP-band attached

b) Completed house

Figure 2 PP-band retrofitted house in Pakistan

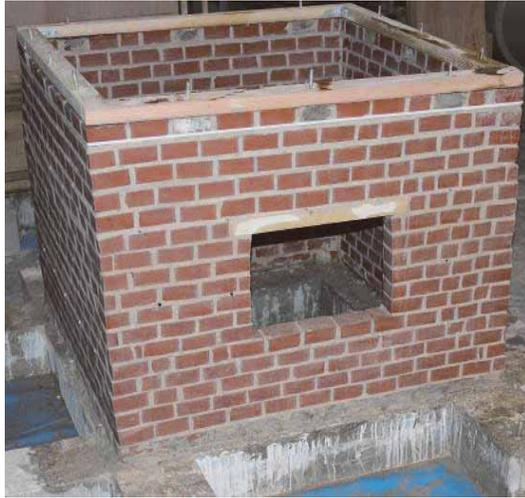
Figure 3 Model house after completion of brick work

Concrete foundation was used to build the houses initially. The base dimensions of the houses were 930 mm x 930 mm, and the height of the house was 720 mm (**Figure 3**). Bricks with the size of 75

mm x 50 mm x 37.5 mm were placed in 18 layers and the wall thickness of the houses was 50 mm. Mortar having cement, lime, sand ratio as (1: 7.9: 20) with w/c as 0.4 (water to cement ratio) was used.

To set up the wooden roof truss, we used cement block with bolts on top layer (**Figure 3**). The form work was removed after 7 days and water was sprinkled for same duration. The 28 days were given to the houses to gain strength. Wooden pieces of 30 mm x 50 mm were placed at the top layer of the brick wall to provide level surface for setting up the wooden roof truss.

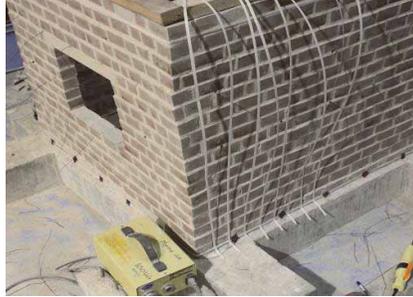
Figure 6 Attachment of vertical PP-band with horizontal strip

Holes at the bottom level of the wall were used to connect PP-band mesh on the inside and outside of the wall with steel wire and perforated steel plates to make out of plane connection. Vertical strips of PP-band were attached at spacing of 50 mm with horizontal strips of PP-band on the bottom of the wall by the ultrasonic welding device (Figure 6). Remaining horizontal PP-bands are connected with both mesh connectivity and out of plane connections. PP-band mesh was wrapped around the door and the window of the models and connected by the ultra-sonic welding device (Figure 7). For the PPN model, the connecting points of PP-band mesh are not connected with the ultrasonic welding device but only weaved to make the mesh (Figure 8). Figure 9 shows the completion of the PPN model. Surfaced finishing with mortar cement, lime, sand ratio as (1:7.9:20) with w/c as 0.4 (water cement ratio) was applied and cured for 7 days. Wooden truss roof was connected to the model houses after plaster was hardened. Plaster applied on the wall helps in removing looseness of PP-band which improves the effectiveness of PP-band by confining effects.

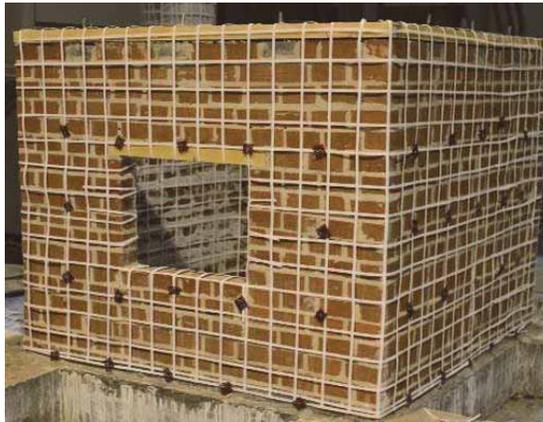
Figure 7 Fully connected PP-band retrofitted house (PPF)

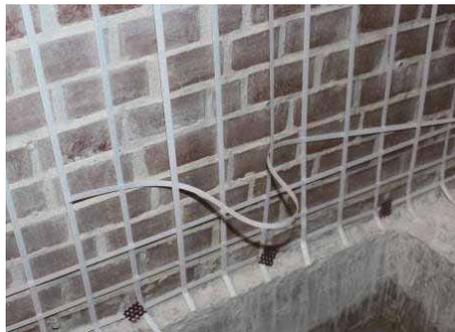
Figure 8 Weaving horizontal PP-band

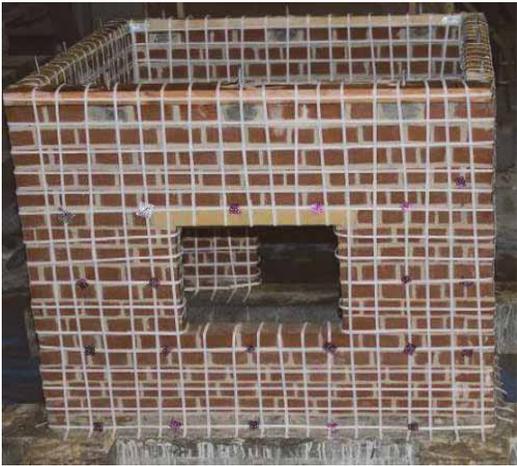
Figure 9 Non connected PP-band mesh house (PPN)

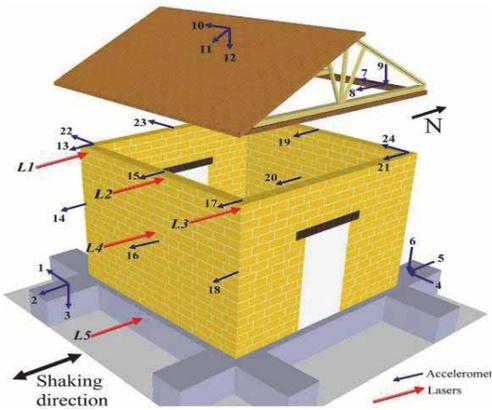
Figure 10 Location of accelerometer and lasers

To measure the global and local behavior of the houses during shaking, accelerometers and laser sensors are used to record the responses of the houses. 24 one dimensional accelerometers were attached to the specimens among those 13 ones in direction of shaking, 7 ones in transverse direction and 4 ones in vertical direction. Total 5 lasers were used to monitor the displacements among that 3 ones on the top of the brick wall, 1 at mid height and 1 at the base level of brick wall. The locations of accelerometers and lasers are shown in **Figure 10**. The measured data is recorded continuously at sampling rate of 1/500 seconds in test cases.

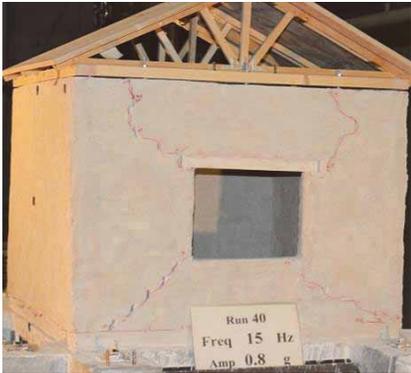
Figure 11 URM house at run-40

No cracks were observed before run-26 (35 Hz and 0.4g). Then small cracks appear near openings and base of the house. Diagonal cracks appear on all side of openings which become prominent and visible after run 31 (30 Hz and 0.8g). The visible diagonal and horizontal cracks at base can be observed (**Figure 11**). Acceleration and displacement responses for last recorded run-36 at both top and mid-level can be seen in **Figures 17, 18, 27 and 28**. The cracks at the base were extending near diagonal cracks up-to run-43 (10 Hz and 0.8g). Furthermore, horizontal cracks appear on the 6th layer from the base and vertical cracks extended from base at the run (**Figure 12**). The model house collapsed at run-44 (5 Hz and 0.4g) by separating itself from the openings and falling of the wooden truss roof.

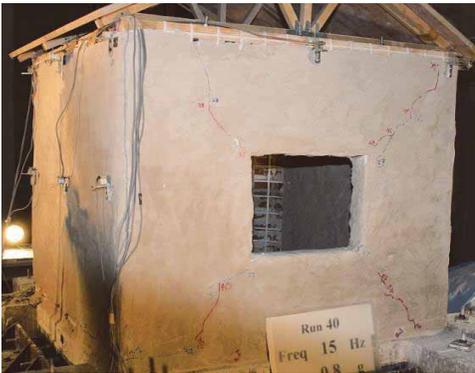
Figure 13 PPF house at run-40

Any significant damage before run-28 (35 Hz and 0.8g) was not observed for the fully connected PP-band house (PPF). After that, cracks from top of opening have initiated. The observed length of hair line cracks were around 90mm ~ 240mm for run-28. Small diagonal cracks near openings appeared after run-32 (25Hz and 0.4g). Acceleration and displacement responses for run-36 at both top and mid-level can be seen in Figs. 19, 20, 29 and 30. Then, diagonal and horizontal cracks at the base were seen at run-37 (20 Hz and 0.8g). The lengths of hair cracks were around 100 mm ~ 250 mm and categorized as slightly non- structural cracked at this run. Clear diagonal cracks at the base and openings were observed at run-40 (**Figure 13**).

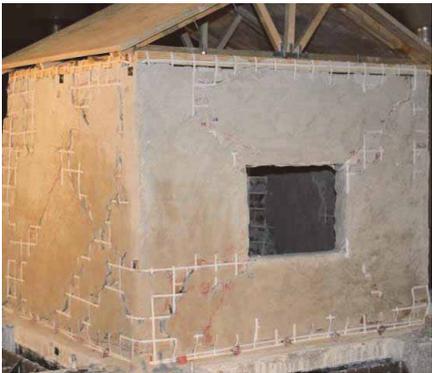
Figure 14 PPF house at run-53

At run-53 (5Hz and 0.8g) the top part of opening has been damaged and plaster on the wall has fallen (**Figure 14**). At this run, observed of lengths of crack were around 100 mm ~ 1,000 mm and widths of cracks were 8 mm ~ 14 mm for model. Cracks can be classified as moderate structural cracked for PPF model. New cracks are observed due to the presence of PP-band mesh. The connections of PP-band were slightly broken. Then the run-54 (2 Hz and 1.2g) was the last loading sequence, PPF house collapsed by breaking of PP-band connections from the base.

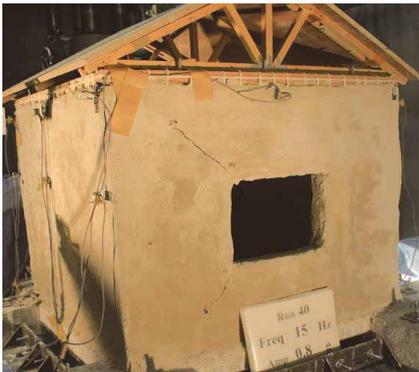
Figure 15 PPN house at run-40

At run-40 (15Hz and 0.8 g) there were diagonal cracks around door and window openings of PPN model (**Figure 15**). The observed lengths of hair line were around 150 mm ~ 300 mm. The model can be categorized as slightly non-structural cracks. Out of plane cracks are observed at run-46 (2 Hz and 0.2g) for the house. The cracks were prominent and visible at this run. Small cracks were length of 400 mm ~ 700 mm and width of 4 ~ 6 mm at this run. Cracks were classified as moderate structural cracks at this run. Acceleration and displacement responses for last recorded run-51 at both top and mid-level of brick wall can be seen in **Figures 25, 26, 35 and 36**.

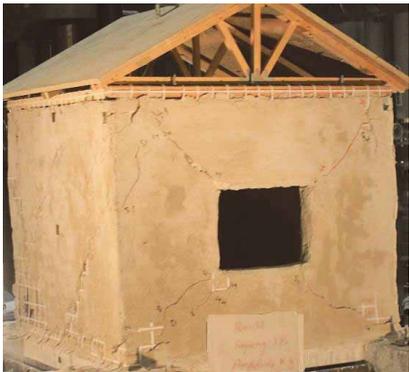
Figure 16 PPN house at run-53

Plaster on the wall fall down from the crack parts of the base at this run. The model was mostly damaged at run-53 (5Hz and 1.2 g) (**Figure 16**). The observed crack widths were around 8mm ~ 14 mm and length were around 100 mm ~ 800 mm at this run. The cracks for out of plane walls were mostly around corners and base of the model. The length and width of cracks around openings are small in comparison to PPF model. The house collapsed at run-54 (2 Hz and 1.2g) in similarity to PPF model by detachment of PP-band from the base.

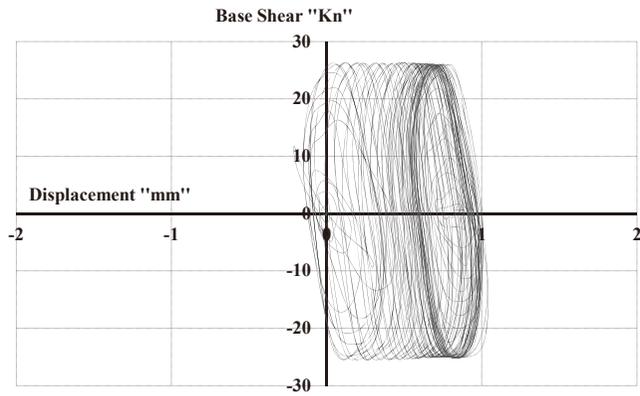
Figure 37 Base shear versus displacement for URM at run-36

Hysteresis curves for the observed data from the experiments performed for different models were plotted for base shear and top displacement (**Figures 37, 38 and 39**). Base shear was calculated by multiplying base acceleration observed with mass of the respective models. The top displacement was observed by the laser sensors at the top of the house. The PPF model shows more elastic and rigid behavior than PPN model (**Figures 38 and 39**). The PPN model shows large energy dissipation in comparison to PPF model.

Stiffness of the structures was calculated by the slope of hysteresis curve in Figs.37, 38 and 39. The data was recorded up to run-36 for URM, whereas PPF and PPN were recorded up to run-51 due to the safety of equipment's. Stiffness degradation curves corresponding to the three models are shown in **Figure 40**. Stiffness degradation curves are described from the initial cracks observed in URM at run-26. Stiffness for both PPF and PPN showed about twice in comparison to URM at run-36. Whereas stiffness of both PPF and PPN shows the same trend of degradation firstly. But the differences of the stiffness for both models have been found at later run.

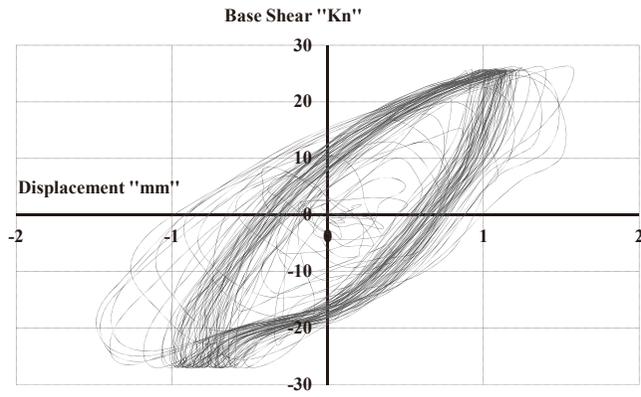
Figure 38 Base shear versus displacement for PPF at run-36

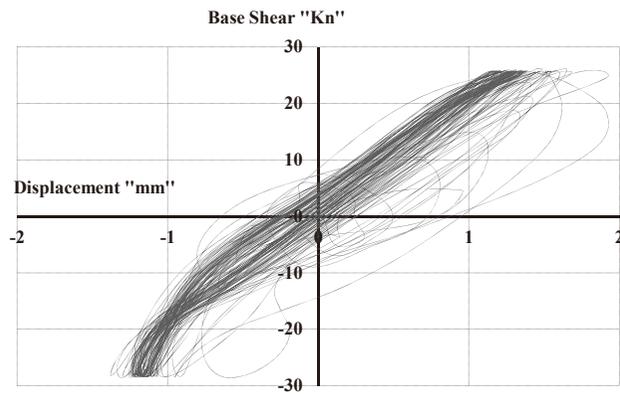
Figure 39 Base shear versus displacement for PPN at run-36

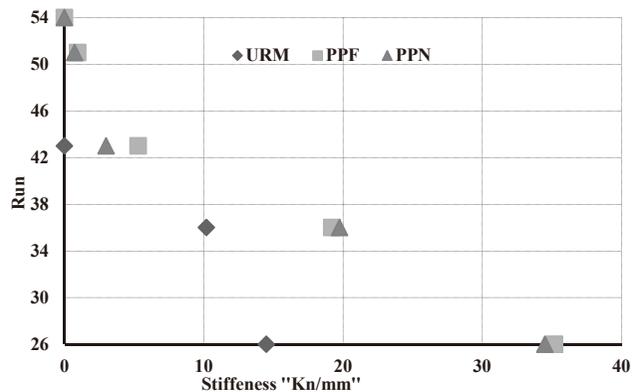
Figure 40 Stiffness degradation curves of houses
