STRUCTURAL EVALUATION OF TRADITIONAL TOWNHOUSE WITH TIMBER THROUGH COLUMN IN JAPAN

Hiromi SATO¹, Mikio KOSHIHARA² and Tatsuya MIYAKE³

ABSTRACT: This paper presents a study of the structural performance of traditional timber townhouses in a historic town in Japan. The aim of this study was to clarify the evaluation method of the structural performance of traditional timber townhouses with through column. The target area has many traditional timber townhouses built in from the late of 18th century to the early 20th century and these townhouses have few structural walls. In this study, the subjects of evaluations were typical townhouses in this area and microtremor measurement, seismic diagnosis and earthquake response analysis were performed. Results of evaluations are compared and it verifies about the difference in evaluation methods.

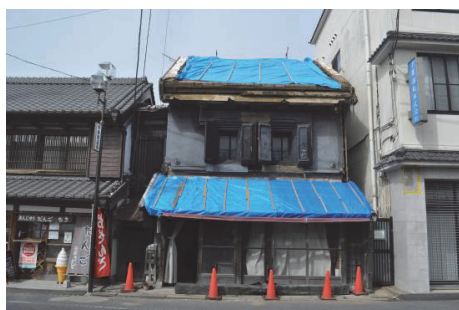
Figure 2. Earthquake disaster observation at March 3 2011 (Townhouse C)

On 11 March, 2011, timber structures suffered a great deal of damage due to the 2011 off the Pacific coast of Tohoku Earthquake. This earthquake destroyed or severely damaged 289 houses in the Katori city including the Sawara district. In the Sawara district, many falls of roofing tiles, collapse of mud walls, and foundation damage were observed as shown in figure 2.

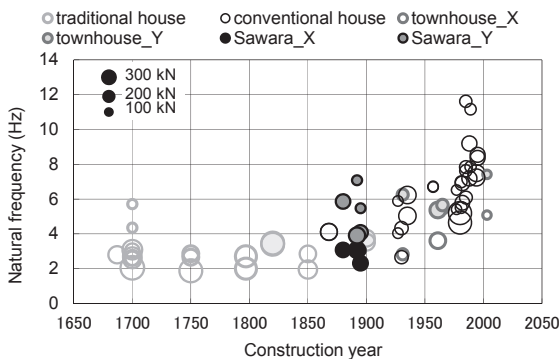
Figure 7. Natural frequency – building year

The relationship between the natural frequency of vibration and the weight of traditional townhouses in this study is compared with the results of previous research (Maekawa 2000 and Inoue 1995), as shown in figure 7. The weight of all buildings compared varies from 129 to 2312 kN. The natural frequency of the X direction of the townhouses of Sawara district is higher than the overall trend. The natural frequency of the first mode of vibration is in inverse proportion to the weight of the building. The buildings are modelled as single-mass systems when applying the natural frequency and the weight of the building. The equivalent stiffness values calculated from this modelling varied from 5.2 to 42.7 kN/mm as shown in figure 8. Most of the equivalent stiffness of the X direction was 15 kN/mm and less.

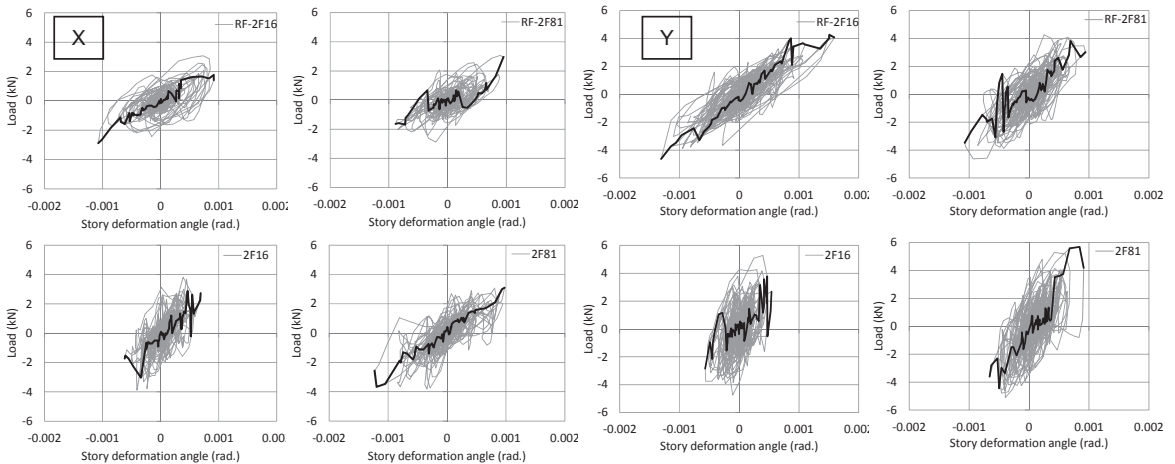
Figure 11. Load – displacement relationship (Townhouse A)

Displacement was calculated by having integrated with the observed acceleration waveform, in consequence the load displacement relationship was presumed, as shown in figure 11. In the small earthquake, the stiffness of the X direction was small; a half of the Y direction, it was not 0.

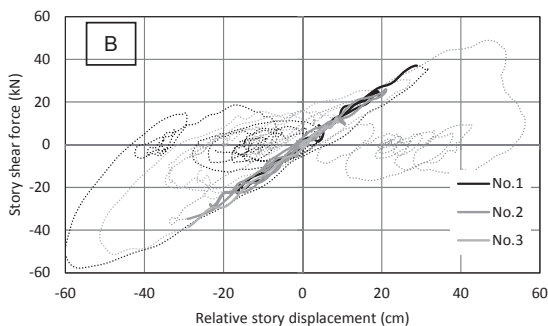
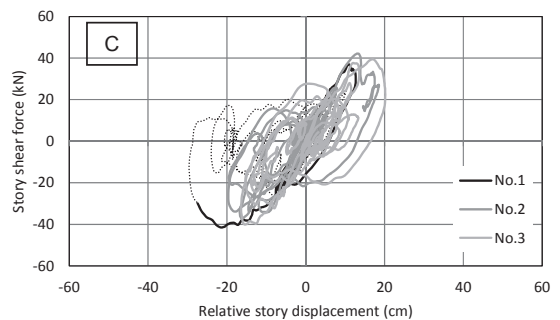
Figure 17. Load - Displacement relationship (case 1, 1FX)

The earthquake response analyses of the mass system model were performed on the three target townhouses. As a result, the maximum story shear force varied from 36.7 to 41.3 kN. The Secant stiffness at the 1/30 radian varied from 134.8 to 356.8 kN/m, as shown in table 7 and figure 17. The structural performance of the townhouse B was smaller than other townhouses therefore it was

collapsed at all input waves because the bending strength of through columns became larger than allowable stress. The maximum story shear force and the secant stiffness of the townhouse C was the highest of the all in this study. However, at the input wave of No.1, the townhouse C was collapsed by the large deformation angle at the first floor. Meanwhile the story shear force and the stiffness of the townhouse A was smaller than that of the townhouse C, the townhouse A was not collapsed.

*broken line: hysteresis curve after the collapse
