Shake table tests on one-quarter scaled models of masonry houses retrofitted with fiber reinforced paint

Key Words: masonry, seismic retrofitting, fiber-reinforced paint, shake table test

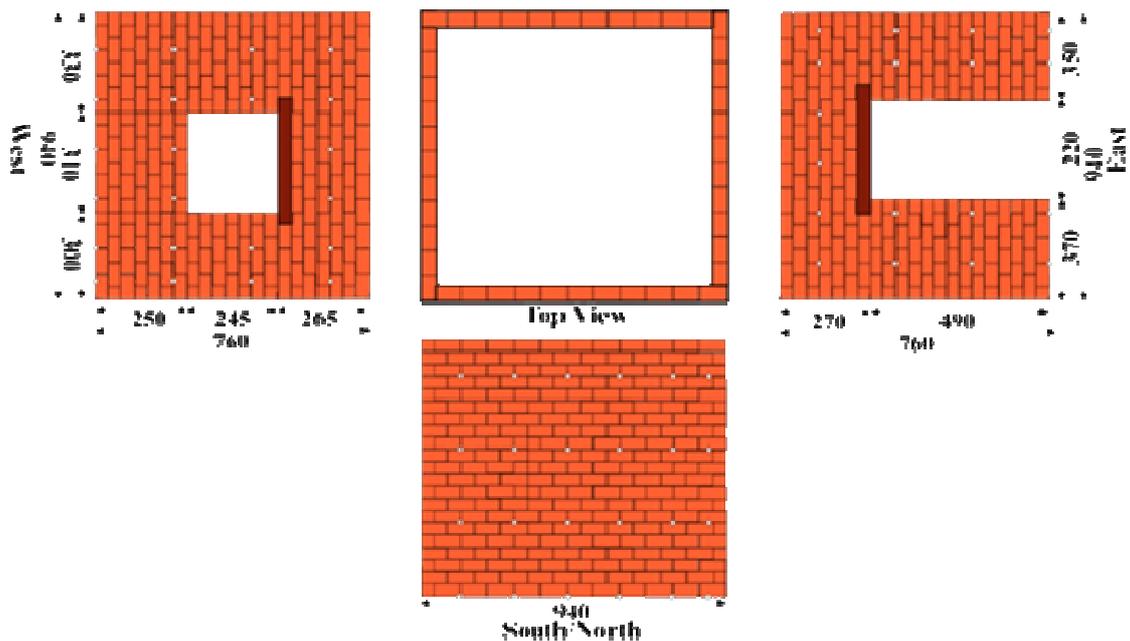
Figure 1. The dimension of the model house

The specimens were built with burnt bricks in reduced scale (1:4). Joints between bricks were filled by mortar with c/w ratio of 0.14 (cement:lime:sand=1:7.9:20). These materials were made in Japan, but the specimens were made with great attention that it could be a suitable replica of masonry buildings in developing countries, following previous experiments conducted by our research group (for example: Meguro et al., 2005). The model was one-story building with roof, with the dimensions of 940mm×940mm×760mm with 50mm thick walls and the sizes of door and window on the east/west walls were 220mm×490mm and 310mm×245mm, respectively as shown in Figure1. The dimension of the bricks used was 75mm×50mm×35mm and the same bricks had been used for the previous experiments conducted by our research group.

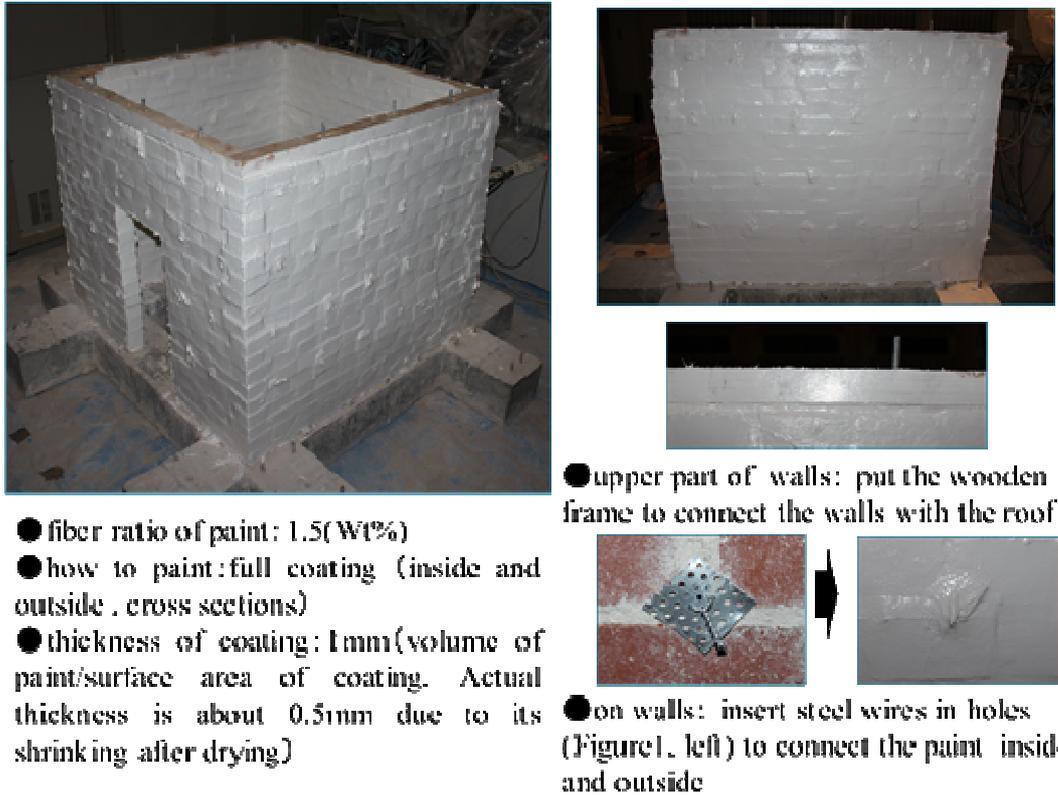
Figure 2. Retrofitting procedure

Straws were put to make the holes placed approximately 200mm pitch as shown in Figure2 while constructing the house model. Before coating SG-2000 on the wall, steel wires were inserted to

connect inside and outside of the wall. After inserting wires, we coated SG-2000 fully on the wall with 1mm thickness.

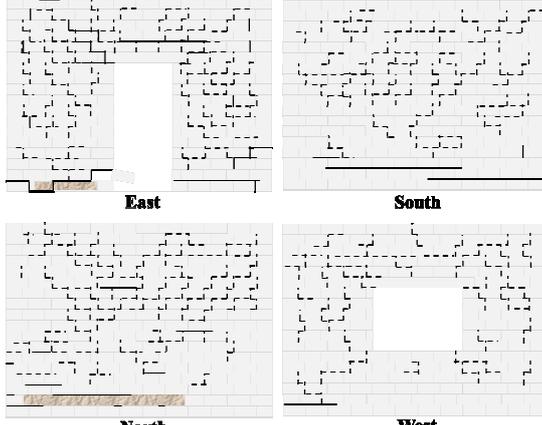
~ Run 39	Run 50
<p>There was no crack observed on the surface of coating and the cracks inside the coating could not be recognized well because of the small motions.</p>	<p>There were heavy damages to mortar joints inside the coating. Also, the coating was heavily damaged on the bottom part of the east wall and therefore there was a separation between the first and the second layer of bricks. There were not so much damages to the coating on the west wall, which had larger stiffness than on the east wall. Therefore, the east wall rotated when shaking with the west wall as the center of rotation.</p>
Run 42	<p>The gray area indicates where the coating had been totally separated from bricks due to the lack of adhesion.</p>
<p>A small damage to coating was observed at around the bottom of the east wall, which has the smallest stiffness of all walls.</p> <p>According to the motion of the wall when shaking, some parts inside the coating were thought to be damaged. On the out-of-plane direction, most of the part from the middle to the top is damaged inside and these damaged parts have been shaken by making those cracks as its hinge.</p>

The crack patterns were investigated and marked after each run. Broken lines were drawn on the part where cracks are only inside the coating, and Solid lines were drawn on the part where the coating was also damaged. The highlight of the crack patterns were in the Table 2.

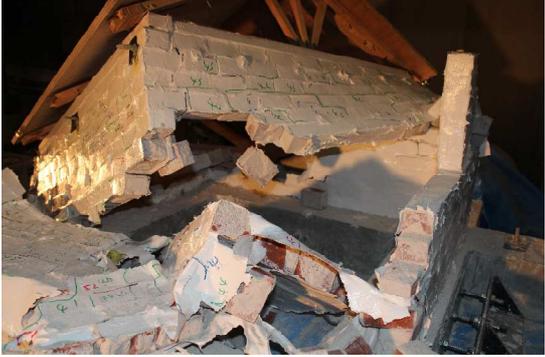
Run 52	Run 54
<p>Some part of the wall on the east wall was separated from the house, but did not fall down as the coating connected the part and the south wall.</p>	<p>Totally collapsed. However, the coating connected bricks after the structure had been broken, which produced some rooms inside the rubble.</p>
<p>Run 53</p>

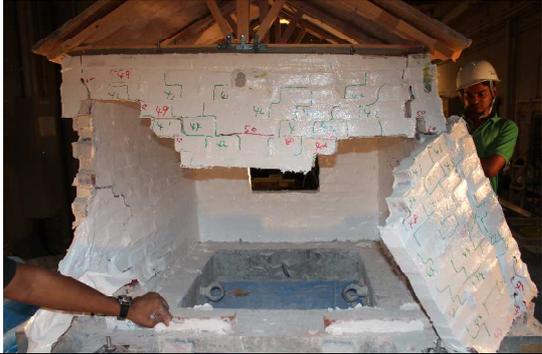
<p>All part of the east wall was separated with the diagonal cracks on the coating that had been produced in the previous runs. So far there was no dust and no bricks falling down inside the house.</p>
